PROJECT NAME:	OPG-213 Pipe Repair and Stabilization	DATE:	12/14/07
ADDRESS/BLOCK & LOT	Union Township Block 15, Lot 55, ROW – 23 Baptist Church Road		
FACILITY TYPE:	Existing Stormwater Discharge	PRIORITY:	>6

SITE PLAN	
OPG-213	
PIPE REPAIR AND STABILIZATION	
DATE: DECEMBER 14, 2007	RIGHT OF WAY, BLOCK 15, LOT 55 UNION TOWNSHIP HUNTERDON COUNTY, NEW JERSEY
SCALE: 1" = 100'	OMNI ENVIRONMENTAL
SHT. NO. 1 of 1	321 WALL STREET PRINCETON, NJ 08540 PH: (609) 924-9821 FAX: (609) 924-9851

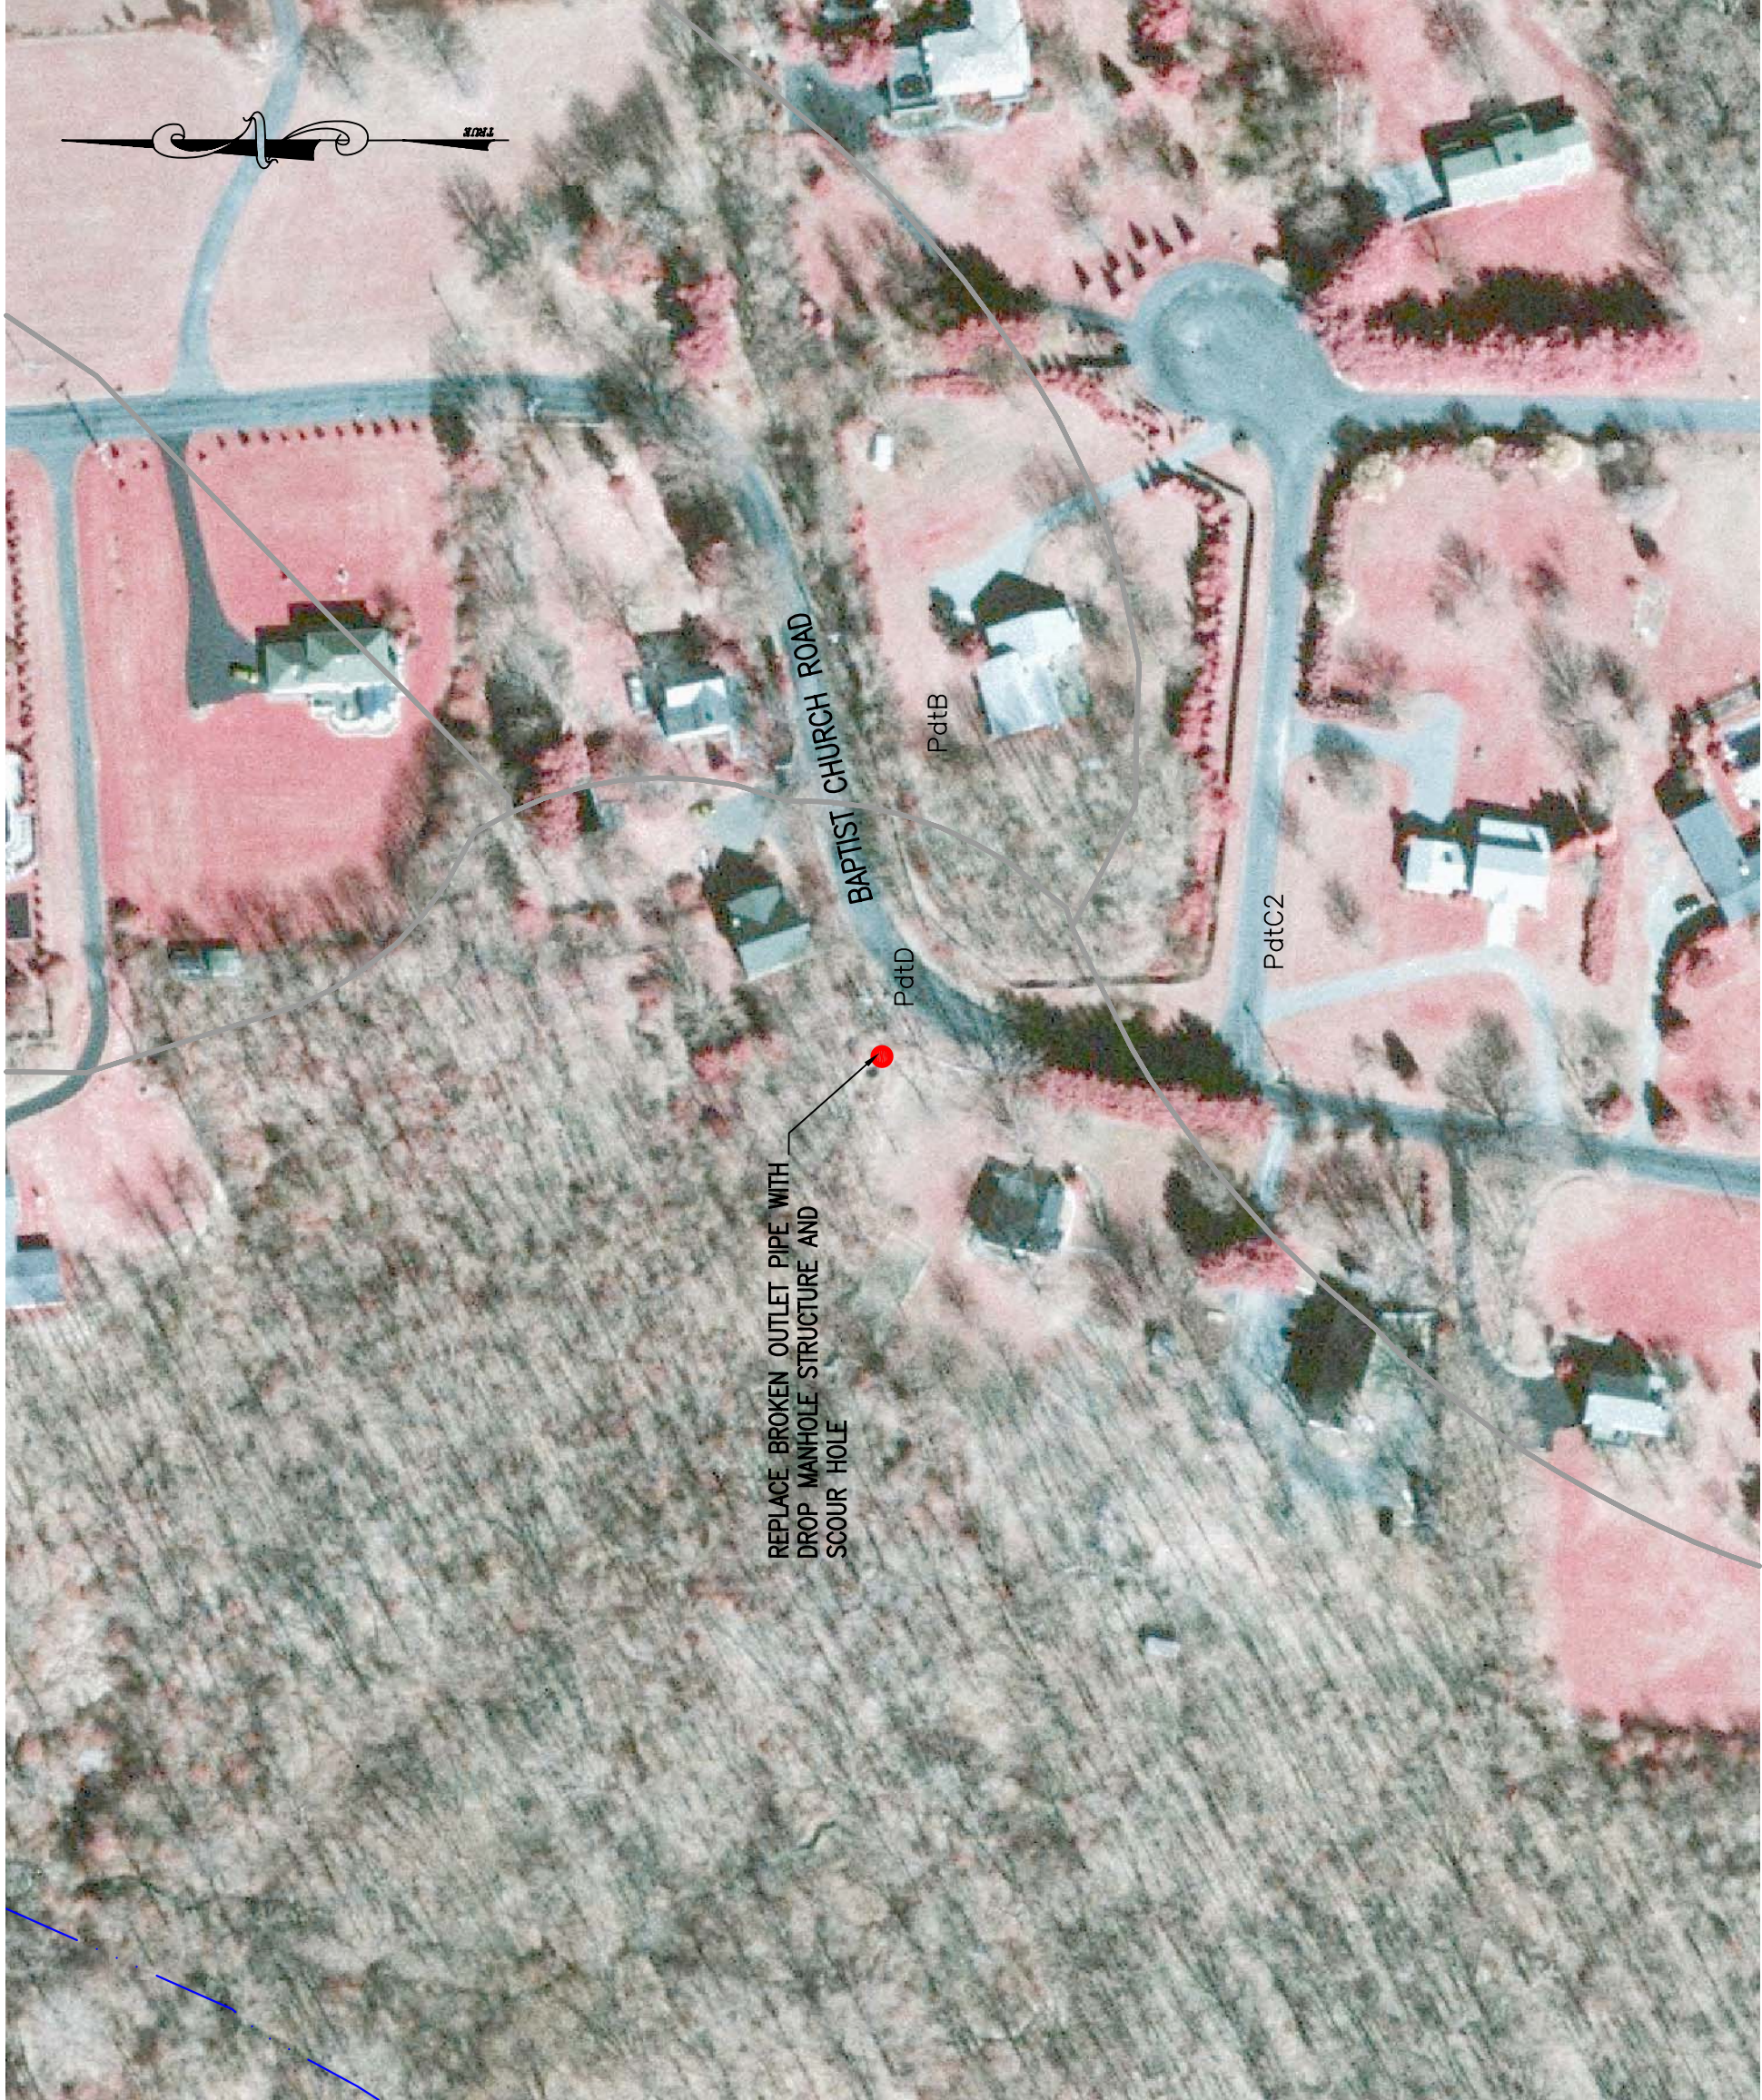
This stormwater outfall serves a portion of Baptist Church Road in Union Township. It appears that stormwater from the outfall has caused significant erosion and sediment deposition at the outfall. There are no water quality or quantity controls for the stormwater discharge. However, stormwater is conveyed to the stream through a series of channels and low-lying swamp areas. In this regard, pollutants are removed and stormwater is treated before reaching the Mulhockaway Creek. The erosion at the outfall is nevertheless contributing sediment and pollutant loads into the watershed and should be stabilized.

The existing discharge drains a portion of Baptist Church Road located near the headwaters of the watershed. In the area, steep slopes are prone to severe erosion from concentrated flows of water. With the original stormwater management approach, runoff is collected in the roadway and discharged through a single pipe outlet. Severe erosion and sediment deposition was observed at the pipe outfall. The last section of pipe has fallen due to undercutting of the soil and is has become partially blocked with sediment. The existing outfall is located approximately 850 feet from Mulhockaway Creek. The outfall is unstable, in poor condition, and contributes to erosion and suspended sediment loads to the Mulhockaway Creek Watershed.

There is little area on the lot to construct a stormwater BMP that would treat the runoff from Baptist Church Road. However, the existing outfall should be repaired to provide a stable outlet that conveys runoff without causing erosion. Based on the site conditions, the most effective approach to the repair and stabilization would be with the installation of a drop manhole structure to dissipate energy and decrease runoff velocities. The existing broken pipe would be replaced by a drop manhole structure that discharges to a scour hole. The scour hole creates a stable outlet for high runoff velocities and traps sediment before being discharged.
