Lockatong Creek

Stream Visual Assessment Results and Restoration Plan

**New Jersey Water Supply Authority
Final Report: September 2008**

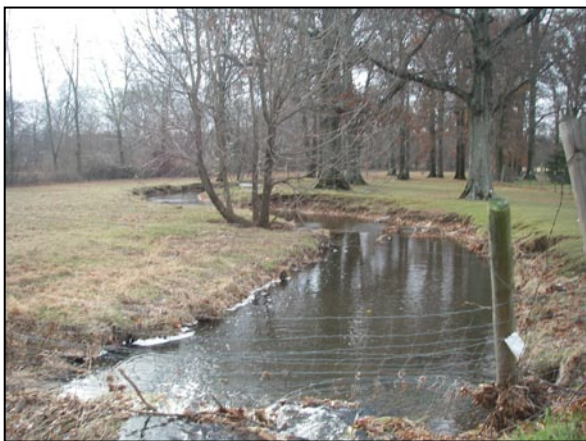
SVAP L-5

SVAP # L-5 (8/good) is located on a tributary to the main stem just upstream of Lower Oak Grove Road. The scores for this site were mostly 8 to 10, although a 6 was given for instream fish cover.

The riparian buffer on each bank is minimal, approximately 10 to 25 feet wide and of poor quality. The reach was identified as a good site for **riparian buffer restoration**. The stream banks were two to three feet high, giving the stream access to the floodplain during storm flows. The substrate was dominated by large shale, and some fine sediment was observed. The channel was sinuous with deep pools and in-

stream cover for fish and macroinvertebrates, although few riffles were observed. A small weir was observed in this reach, constructed of rock and geotextile. The weir backed up water slightly; fewer riffles were observed upstream of the weir than downstream. Land use in the vicinity of the reach consisted of residential property and large fields.

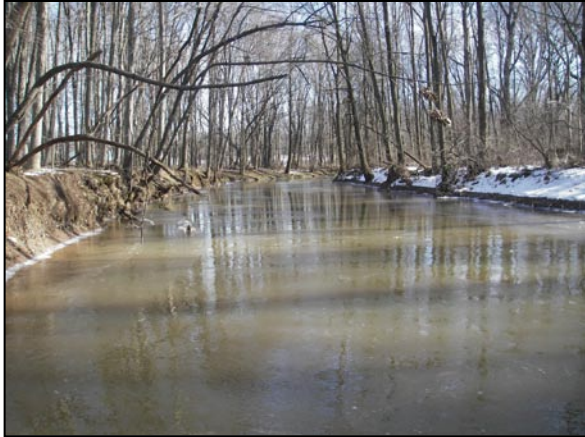
SVAP L-6

SVAP # L-6 (6.4/fair) is located on a small tributary just downstream of SVAP #L-5 and Lower Oak Grove Road, between the bridge and the confluence with the mainstem of Locketong Creek. The assessment was performed from the road, as the reach was fenced. The scores for this reach ranged from a 1 for the riparian zone and a 2 for canopy cover to a 9 for channel condition.

The riparian buffer on each side was grass to the top of the banks with a sparse overstory of mature trees and no understory. The stream banks were approximately two feet high and the stream had good floodplain access. Good meanders were

observed. Livestock appeared to have access to the stream, although none were observed at the time of the assessment. The land use on the left bank was residential, and on the right bank was residential and agriculture. The reach was identified as a good site for **riparian buffer restoration** and the **River-Friendly Farm program**.

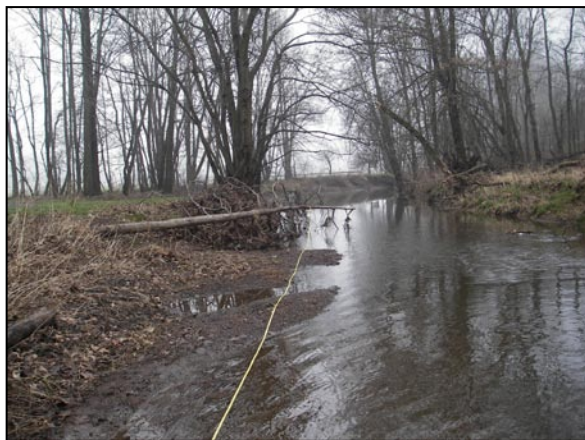
SVAP I.-13

SVAP # L-13 (7.5/good) is located on the Lockatong Creek mainstem downstream of the Route 12 bridge. The scores at this site ranged from a 5 for instream fish cover to a 9 for several parameters.

The riparian corridor was forested on both sides of the channel, with moderate coverage by invasive species, particularly multi-flora rose. The stream banks were two to four feet high, allowing access to the floodplain during large storm events (three to five year events). Erosion was observed along both banks. The dominant substrate observed was gravel, with some larger

material. Algae and sediment covered a majority of the substrate. The channel was relatively straight with little change in the velocity regime until the end of the survey reach, where meanders and riffles were observed. The land use in the vicinity of this reach was primarily forest.

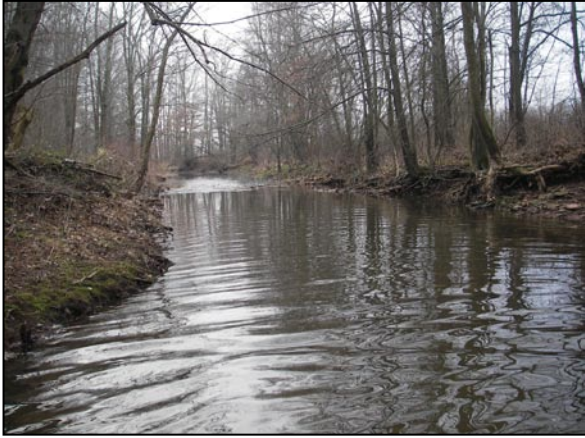
SVAP L-1

SVAP #L-1 (6.8/fair) is located in Kingwood Park on the upstream side of Union Road on the main stem of Lockatong. The scores for this reach ranged from a 1 for pools and a 3 for instream fish cover to a 9 for water appearance.

The riparian corridor was forested with some disturbance from public access on the park side. The banks were one to three feet in height and some areas of erosion were observed. Access to the floodplain was moderate. The dominant substrate observed was gravel; very little fine sediment or sand was observed. The channel lacked sinuosity and riffle pool morphology. Exposed roots on the banks and mid-channel bar

formation were indicative of active widening and deposition in the reach. The land use in the vicinity of this reach was forest and park land.

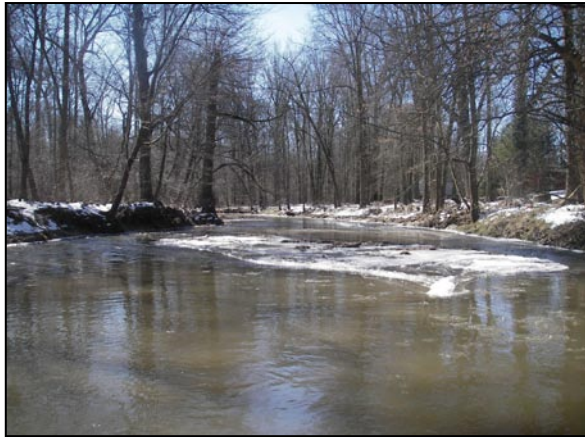
SVAP L-2

SVAP # L-2 (7.1/fair) is located downstream of Union Road and SVAP #L-1. The scores for this reach ranged from a 6 for bank stability and pools to a 10 for invertebrate habitat.

The substrate was dominated by cobble, as opposed to the gravel substrate observed upstream of the Union Road bridge. The surrounding land use consisted of forest and residential / agricultural fields.

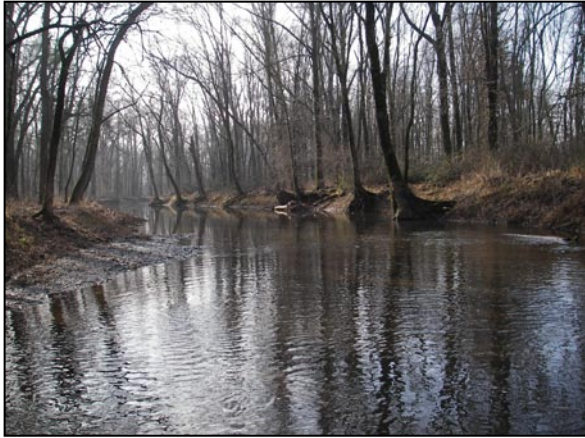
SVAP L-11

SVAP # L-11 (8.1/good) is located on the upstream side of Thatcher Road on the mainstem of Lockatong Creek. The scores for this reach ranged from a 5 for bank stability to a 9 for invertebrate habitat.

There were areas of active erosion along both banks from high flow events. The substrate composition was dominated by gravel, and some mid-channel bars were present. The reach had a meandering pattern with a riffle and glide sequence, and some pools. The land use in the vicinity of this reach was primarily forest.

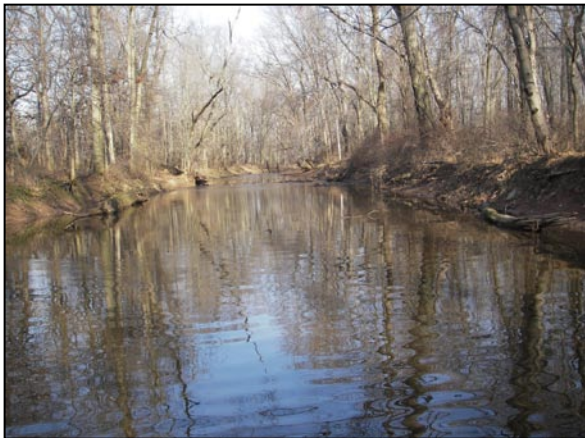
SVAP L-12

SVAP # L-12 (8.2/good) is located downstream of Thatcher Road and SVAP #L-11. The scores for this reach ranged from a 5 for pools and a 6 for bank stability to 9 for several parameters.

A tributary on the right bank at the end of the reach was an active sediment source. Several abandoned vehicles were observed along the

tributary. The channel was mainly shallow with some riffles and an absence of pools. The land use near this reach included forest.

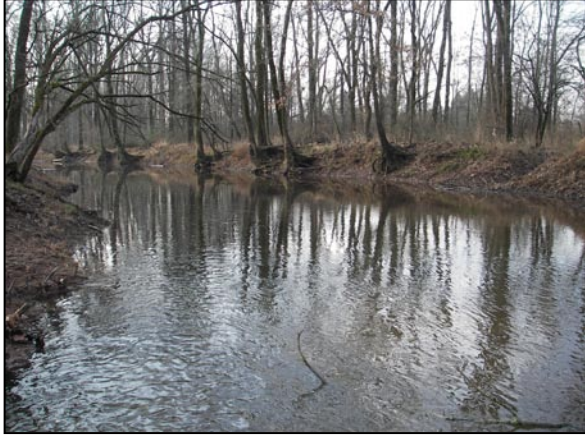
SVAP L-4

SVAP #L-4 (7.5/Good) is located on the mainstem of the Lockatong, upstream of Barbertown-Point Breeze Road. The scores for this reach ranged from 5 for instream fish cover and pools to 9 for riparian zone, bank stability and water appearance.

The riparian corridor was primarily forested. The banks were approximately two to four feet high, but were in good condition, well vegetated and gently sloped. The channel was relatively straight, but did not appear to have been altered. The reach contained little in-stream habitat diversity, lacking a good pool/riffle structure. Some algae was observed in the channel.

The land uses near this reach include forest and agriculture, which did not appear to be negatively impacting the stream. The nearby agricultural properties could be targeted for the **River-Friendly Farm** program.

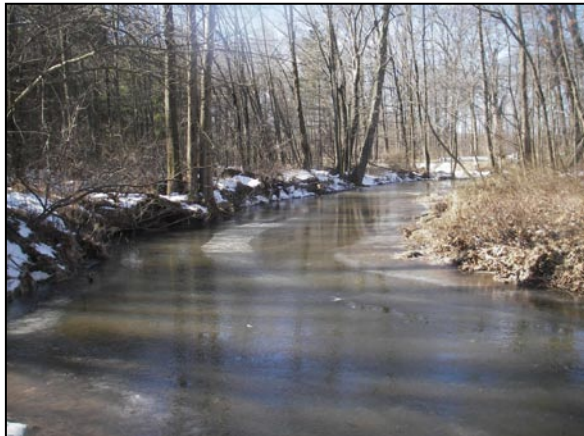
SVAP L-3

SVAP # L-3 (8.2/good) is located on the mainstem of the Lockatong, downstream of Barbertown-Point Breeze Road and SVAP L-4.

This reach had good access to the floodplain, and the banks were in average condition, although some exposed tree roots were observed. Exposed roots can be an indicator of erosive flows and channel movement. Some sediment deposition was observed on the inside of slight bends. No significant erosion of the banks was observed. Good riffle and some average pools were observed within the reach. As observed at SVAP #L-3, the reach was relatively straight, but did not

The land uses near this reach included forest, a small amount of residential and agriculture. None of these land uses appeared to be negatively impacting the reach.

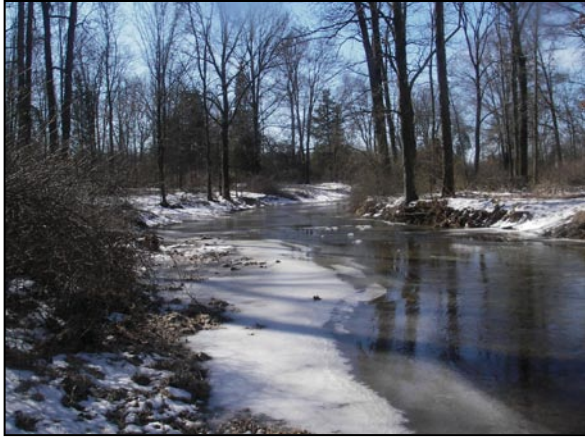
SVAP L-09

SVAP #L-09 (7.9/Good) is located on a tributary known as Muddy Run, which enters the mainstem Lockatong east of Route 519, between SVAP #L-3 and SVAP #L-17. SVAP #L-09, located upstream of Union Road, was the most upstream of the five assessments performed on Muddy Run. The scores for this reach ranged from a 6 for pools to a 9 for canopy cover.

The banks in this reach were one to three feet in height with some undercutting. The stream had good floodplain access on at least one bank in all areas of the reach. Some erosion of the banks was observed. There was a bankfull bench formed by point bars on some bends. The bench

contained some vegetation, but also appeared to be submerged at times. The riparian corridor was forested and contained some invasive species, including multiflora rose, and the understory was sparse. The sinuosity of this reach was considered good. Land use within the vicinity of the reach was primarily forest and one residential property.

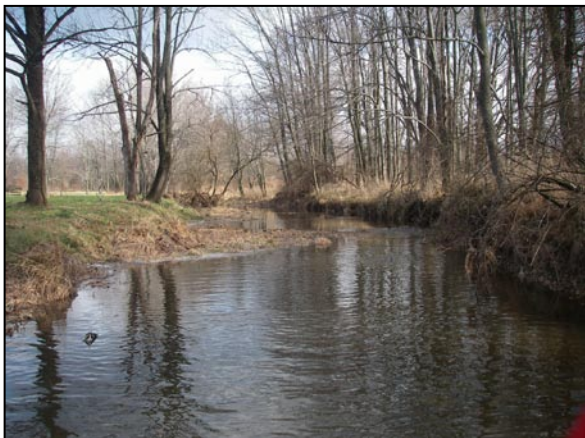
SVAP L-10

SVAP #L-10 (8.1/Good) is located on Muddy Run, downstream of Union Road. Two tributaries entered this reach of Muddy Run, one on the left bank approximately 150 feet downstream of Union Road and the second also on the left bank farther downstream. The first tributary was undercut and incised, while the second appeared to be in good condition. The scores for this reach ranged from a 6 for pools and a 6.5 for riparian zone to a 9 for water appearance and nutrient enrichment.

The land use in the vicinity of this reach included forest, agriculture and residential. The agricultural use on the right bank included houses, barns, a meadow area and pasture containing horses. A fence was present along the stream, there was no apparent animal access to the stream and no apparent manure impact to the stream. The property could be targeted for the **River-Friendly Farm** program.

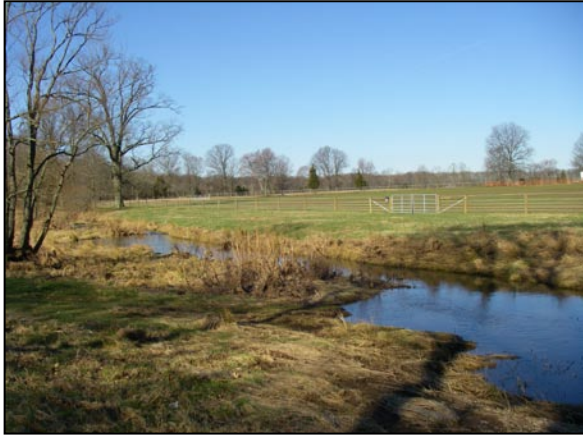
SVAP L-07

SVAP #L-07 (7.3/Fair) was located on the upstream side of Muddy Run Road on Muddy Run. The scores for this reach ranged from 6 for several parameters, including bank stability, to 8 for other parameters.

The banks in this reach were three to four feet in height with some erosion. The stream's floodplain access was poor. This reach was relatively straight, and the dominant substrate was mixed, including cobble, shale and a small amount of sand. The sinuosity improved farther upstream. A few good riffles were observed, but the majority of the reach was flat water. The riparian corridor was adequate within the reach; upstream of the reach, a residential yard was a recommended **riparian buffer improvement site**. A drain was also observed from beneath the yard, and was likely yard drainage. A road ditch was present on the left bank, and created a scour hole where it entered the stream. The land use in the vicinity of this reach was primarily forested, with a few residential properties.

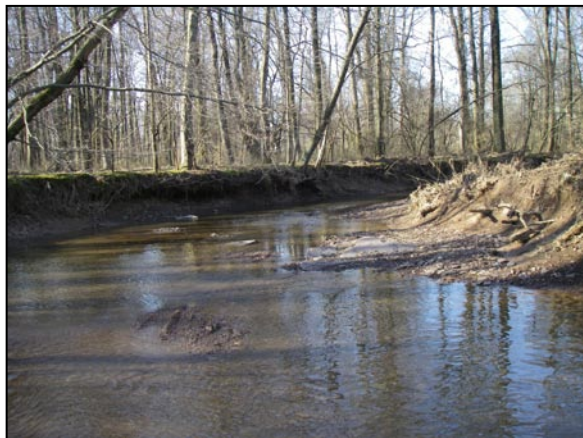
SVAP L-08

SVAP #L-08 (6.1/Fair) is located downstream of Muddy Run Road on Muddy Run. The scores for this reach ranged from a 1 for riparian zone to 8 for channel condition, hydrologic alteration and bank stability.

This site is a candidate for **riparian buffer improvement** and for the **River-Friendly Farm** program. Due to the plant communities present, the improvement could be as simple as establishing no-mow corridors. Agricultural best management practices should be considered for the adjacent property. The riparian zone and canopy cover scores were the primary reasons for the very low SVAP score of this reach.

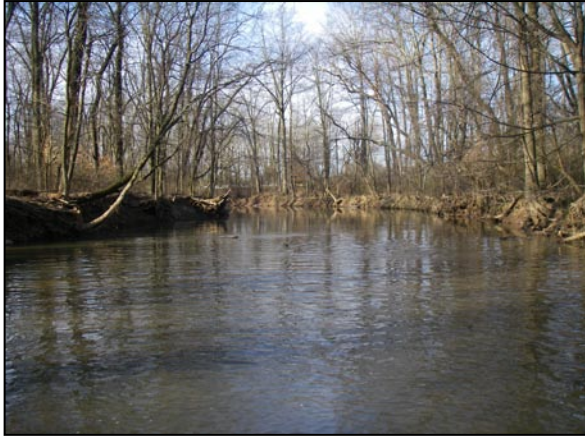
SVAP L-20

SVAP #L-20 (7.7/Good) is located downstream of Muddy Run Road, on Muddy Run. This reach is downstream of SVAP #L-08 and continues to the confluence of Muddy Run with the mainstem Locketong Creek. The scores for this reach ranged from 5 for bank stability to 9 for riparian zone.

This reach exhibited banks much higher than those observed upstream, adjacent to Muddy Run Road at SVAP #L-08. The floodplain access was poor in this reach. The banks were eroded in several areas. The sinuosity in this reach was considered good. The dominant substrate was gravel and larger shale; there were areas of fine

sediment deposition. Average riffles were observed, and some point bars had formed. The reach was overwidened, due to the excessive quantity and velocity of water moving through the reach. There was also evidence of ATV traffic through the stream channel.

agricultural property (see SVAP #L-08). The use of ATVs in the stream should be addressed. The reach could be considered for **structural bank stabilization**, such as reconnection with the floodplain, if the cause of the stream incision is addressed. Without addressing the cause of the incision, any structural stabilization will fail.

Structural stabilization was recommended at one site on Muddy Run Road (SVAP #L-20). This reach exhibited poor floodplain access, eroded banks and overwidening. Structural stabilization could include installation of structures such as vanes, J-hooks or barbs constructed of rock or

wood. Depending on the extent of the restoration needed, such projects may cost from \$25,000 to \$500,000 for construction.

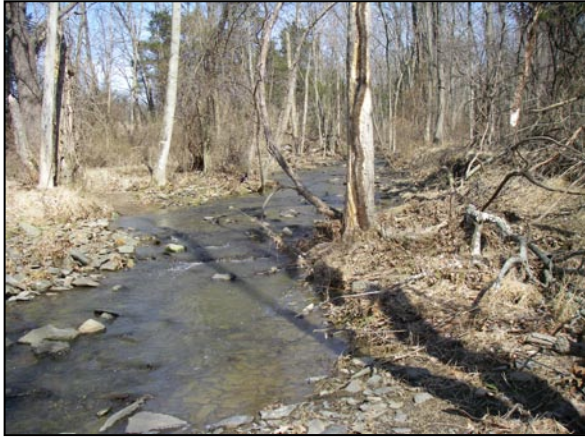
SVAP L-17

SVAP #L-17 (7.8/Good) was located on the upstream side of Route 519, slightly west of Byram-Kingwood Road. The stream flows quite close to Route 519 in the more downstream portion of the reach. The scores for this reach ranged from 6 for pools, water appearance and nutrient enrichment to 9 for invertebrate habitat and canopy cover.

The banks were one to four feet in height, and the stream's access to the floodplain was better in the downstream part of the reach. Slight to moderate bank erosion was observed, but not at a level that was considered a problem. This reach was relatively straight, movement is constrained by

the nearby road. The water was slightly murky; significant rain fell a few days prior to the SVAP. The channel bed exhibited a great deal of topographic variation. A few good riffles were observed, but the spacing in between the riffles was very long. A few average pools were also observed. Some deposits of sand, perhaps from road runoff, were observed. A tributary was observed on the left bank near the downstream end of the reach and a drainage swale from the road was observed mid-reach (right bank).

The land uses near this reach include forest, roadway, agriculture and residential; with the exception of the road, none appeared to be negatively impacting the reach.

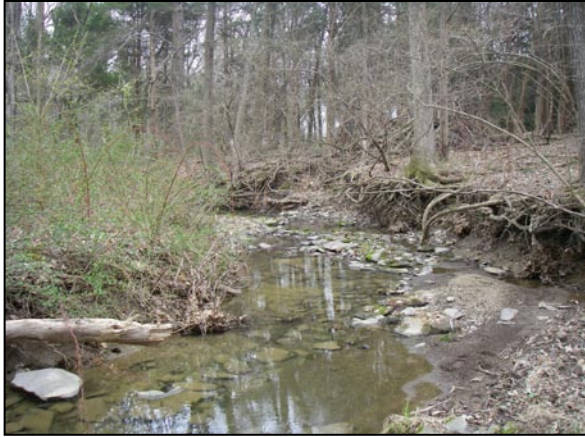
SVAP L-16

SVAP #L-16 (7.9/Good) is located on a small tributary to Lockatong Creek, upstream of Byram-Kingwood Road. This tributary enters the left bank of the mainstem, west of Route 519. The scores for this reach ranged from 7 for bank stability, water appearance and nutrient enrichment to 9 for riparian zone and invertebrate habitat. Despite the high quality riparian habitat, the site received a very low score for observed macroinvertebrates.

The riparian corridor was primarily forested, including a forest stewardship area on the left bank. Some fields were observed set back from the stream somewhat. The right bank near the road crossing is a potential target for **riparian buffer improvement**. The banks varied in height from less than one foot to three feet. The stream had access to the floodplain on at least one side of the channel in all areas. It appeared that the stream overtops the bank occasionally, but there is room for water to dissipate energy and sediment. The dominant substrate was cobble and larger material, with some bedrock. The reach contained a few good meanders, and the sinuosity through the reach was average. Many downed trees were observed, along with some areas of erosion.

The stream appears to experience high flows, which could account for the low macroinvertebrate score. Some fine sediment deposition was observed, primarily on point bars and in meanders. The rocks were somewhat slimy and green, indicating potential nutrient enrichment. The water was slightly murky, but heavy rain fell the day prior to the assessment, which also could contribute to the low macroinvertebrate score. Road ditches were present on both banks. This reach looks ‘messy’ or problematic in the photographs, but the assessment indicated that it was actually in reasonable condition.

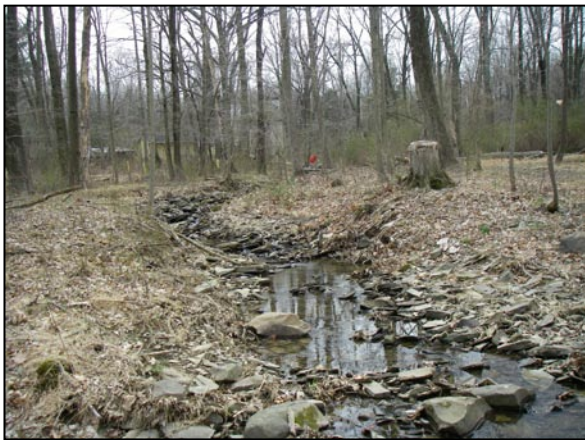
SVAP L-22

SVAP #L-22 (8.0/Good) is located on a small tributary that enters the right bank of the mainstem Lockatong Creek west of Route 519. The SVAP site was located upstream of Federal Twist Road. This tributary had less flow than some other areas that were assessed, the assessors anticipated that this reach is dry much of the year. The scores for this reach ranged from 6 for instream fish cover and pools to 8 for several parameters.

The banks were mostly low, with a few higher points. The stream had good floodplain access. The reach contained decent riffles, but no significant pools were observed. One area of

severe erosion was observed. It appeared as if lawn debris was dumped in a drainage swale or headcut on the left bank. The riparian corridor was primarily forested; there is an area upstream of the reach where a residential yard is relatively close to the stream. Ditches were observed on both banks of the stream at the road crossing; these ditches were sources of sediment to the stream. Some rip rap was placed on the left bank at the road crossing.

The land use in the vicinity of this reach included forest and residential. An agricultural property was present downstream where livestock potentially had access to the stream. That property should be targeted for the **River-Friendly Farm** program.

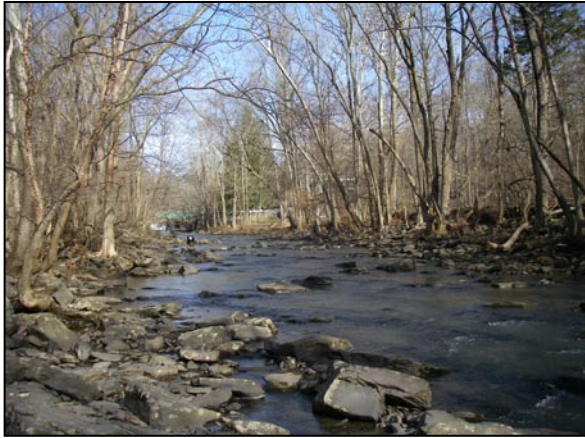
SVAP L-21

SVAP #L-21 (8.5/Good) is located on a small tributary that enters the right bank of the mainstem Lockatong Creek west of Route 519, downstream of the #L-22 tributary. This site was located downstream of Federal Twist Road.

2008. This reach could be a target for **riparian buffer improvement** to complement what the landowner has already accomplished. A large amount of multi-flora rose was observed in the riparian corridor.

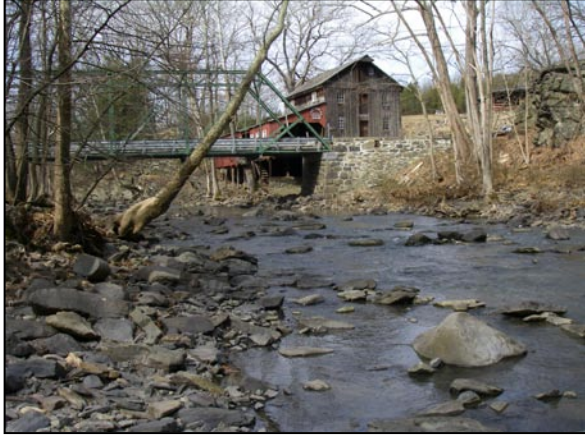
SVAP L-18

SVAP #L-18 (7.7/Good) is located downstream of Milltown Road on the mainstem of the Lockatong. The scores for this reach ranged from a 6 for pools to 9 for several parameters.

The land use in the vicinity of the reach was primarily forested. A state wildlife management area was present on the right bank. Milltown Road was present on the right bank, but was an adequate distance from the stream.

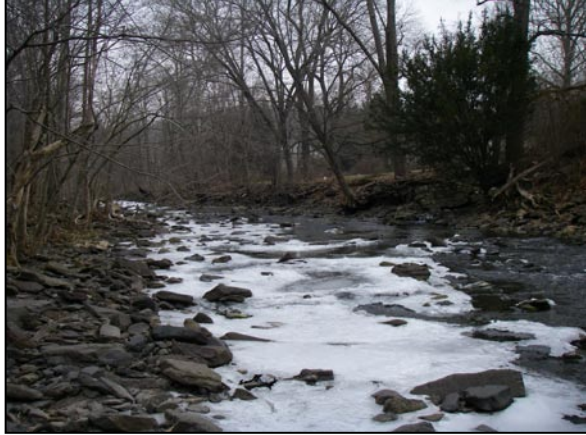
SVAP L-19

SVAP #L-19 (7.8/Good) is located downstream of Strimples Mill Road on the mainstem of the Lockatong. The scores for this reach ranged from 7 for instream fish cover and canopy cover to 9 for riparian zone.

elevation. The banks were very rocky and in good condition, with no erosion observed. The rocks had a slight coat of fine sediment. A drainage swale was present on the left bank near the downstream end of the reach.

Although the riparian corridor of the assessed reach consisted of forest, upstream of Strimples Mill Road the land use included an old saw mill, an autobody shop/junkyard and pasture containing a few sheep. Peacocks were also observed near the reach.

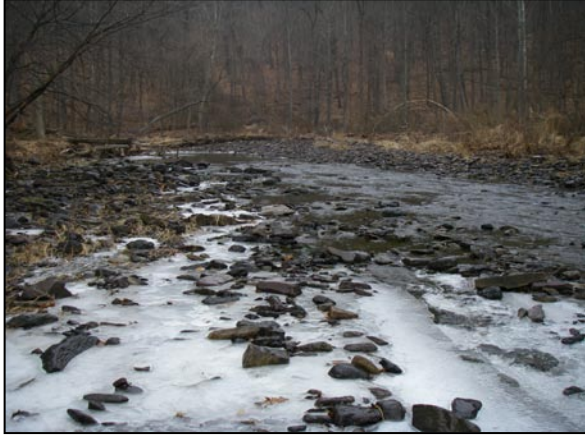
SVAP L-14

SVAP #L-14 (7.4/Fair) is adjacent to the Wescott Preserve, adjacent to Raven Rock Road. The Preserve is owned by Hunterdon County. The scores for this reach ranged from 6 for nutrient enrichment and instream fish cover to 9 for water appearance.

where the bedrock cliff was not a boundary condition and the stream can move. Despite the high banks, the stream appeared to be in a stable condition. Good riffles and some deep pools were observed, and the sinuosity was average. Rocky point bars were observed. Many exposed tree roots were observed, but the banks were protected from erosion by rocks.

Several small drainages and overland flow originated in the Wescott Preserve and a tributary (mapped) entered the left bank mid-reach. The water was clear, but the rocks were slimy and green. The residential area on the left bank in the upstream section of the reach should be targeted for a **riparian buffer improvement** effort, as lawn area was present adjacent to the stream.
