PROJECT NAME:	OPG-369 Outlet Stabilization (Country Acres)	DATE:	12/14/07
ADDRESS/BLOCK & LOT	Union Township Block 18, Lot 11 (Discharge) – 96 Country Acres Dr.		
FACILITY TYPE:	Existing Stormwater Outfall	PRIORITY:	>6

SITE PLAN	
COUNTRY ACRES OUTLET REPAIR	
DATE: DECEMBER 14, 2007	BLOCKS 17, LOT 4, 15 & 4, 16 BLOCKS 18, LOT 11 UNION TOWNSHIP HUNTERDON COUNTY, NEW JERSEY
SCALE: 1" = 100'	OMNI ENVIRONMENTAL
SHT. NO. 1 of 1	321 WALL STREET PRINCETON, NJ 08540 PH: (609) 924-8821 FAX: (609) 924-8851

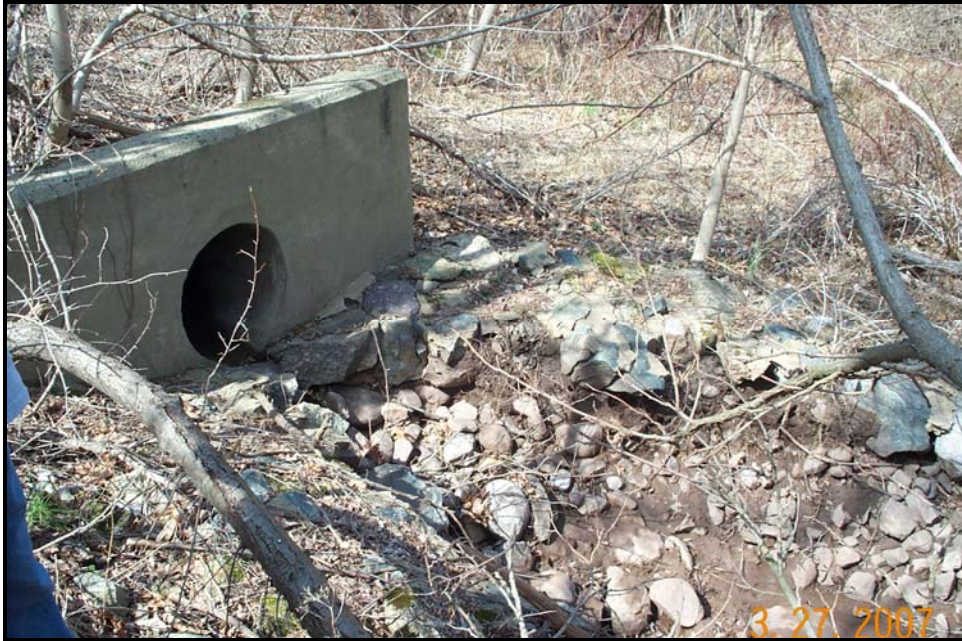
An existing culvert and headwall were observed in the field. Large rocks were observed at the outfall and appear to be the remnants of a rip-rap apron. The stormwater discharge did not appear to be maintained, and trash and debris were observed directly downstream of the headwall. Evidence of erosion caused by high stormwater velocity was observed along the side slopes of the outfall channel. The flow was beginning to undermine and erode soil around the headwall.

Stormwater outfall

There is little area to construct a stormwater BMP that would treat the runoff from Country Acres Drive. However, the existing outfall should be repaired to provide a stable outlet that conveys runoff without causing erosion. Based on the site conditions, the most effective approach to the repair and stabilization would be with the installation of a properly sized scour hole. The area immediately downstream of the discharge would be stabilized and cleaned of trash and debris. The scour hole creates a stable outlet for high runoff velocities and traps sediment before being discharged.

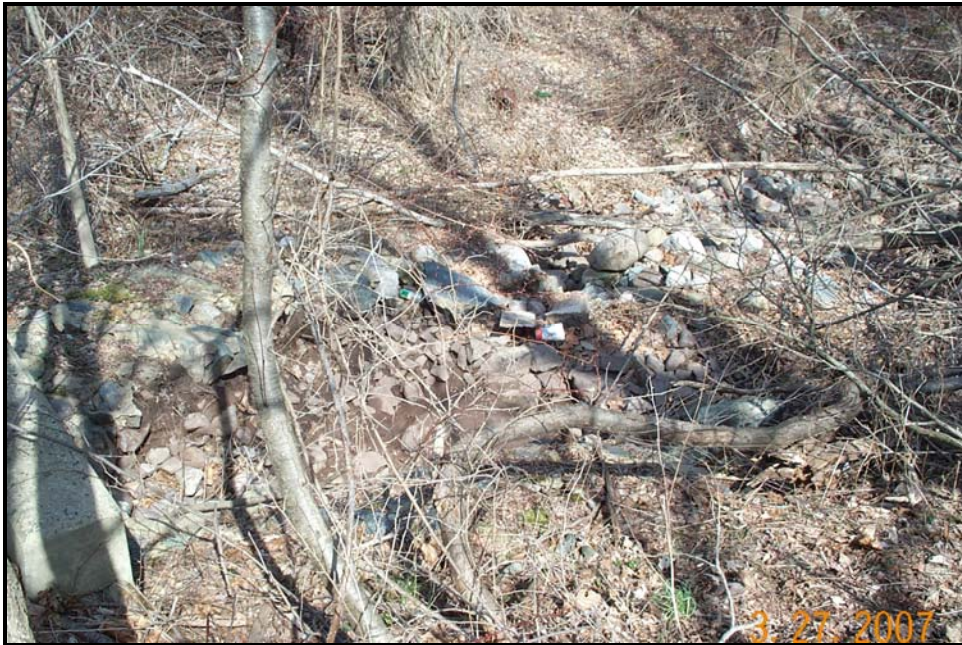
Sediment and trash deposition

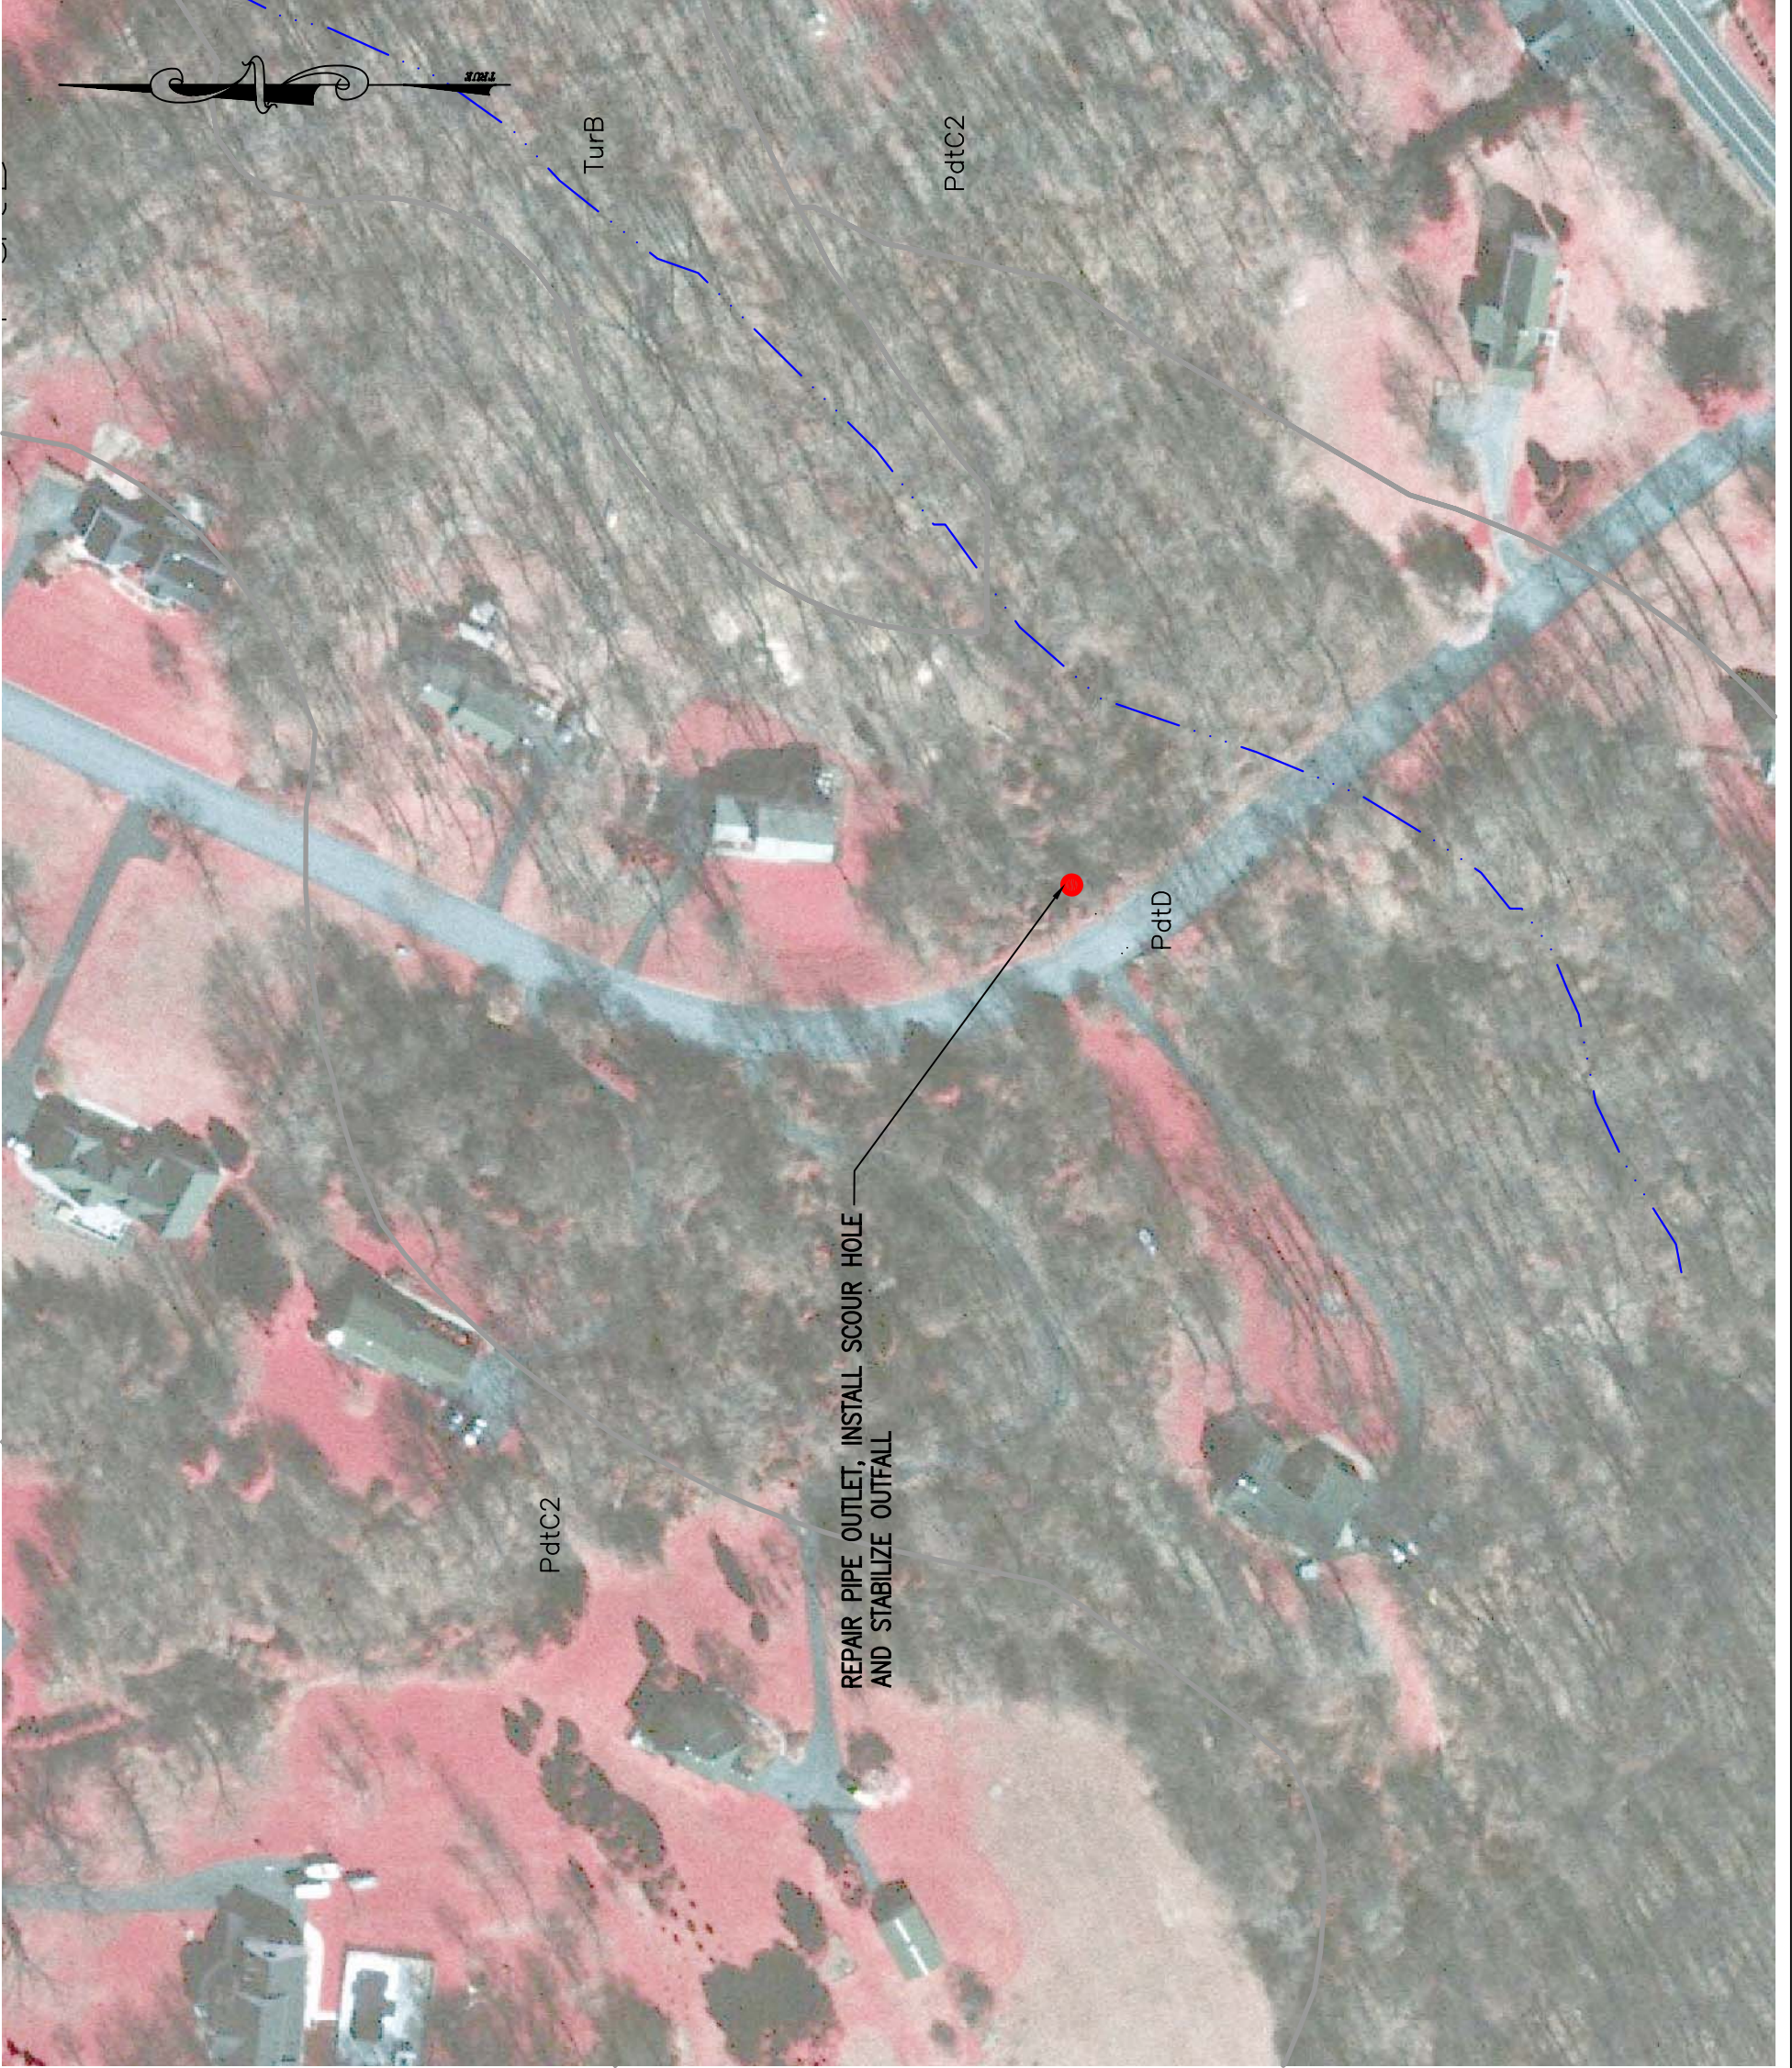
SOILS:
PdtC2 - Pattenburg Gravelly Loam, 6-12% Slopes, eroded
PdtD - Pattenburg Gravelly Loam, 12-18% Slopes
TurB - Turbotville Loam, 2-6% Slopes
