Characterization and Assessment of the Cedar Grove Brook Watershed

September 2009 – Final Draft

Jen Zhang, Watershed Protection Specialist
NJ Water Supply Authority

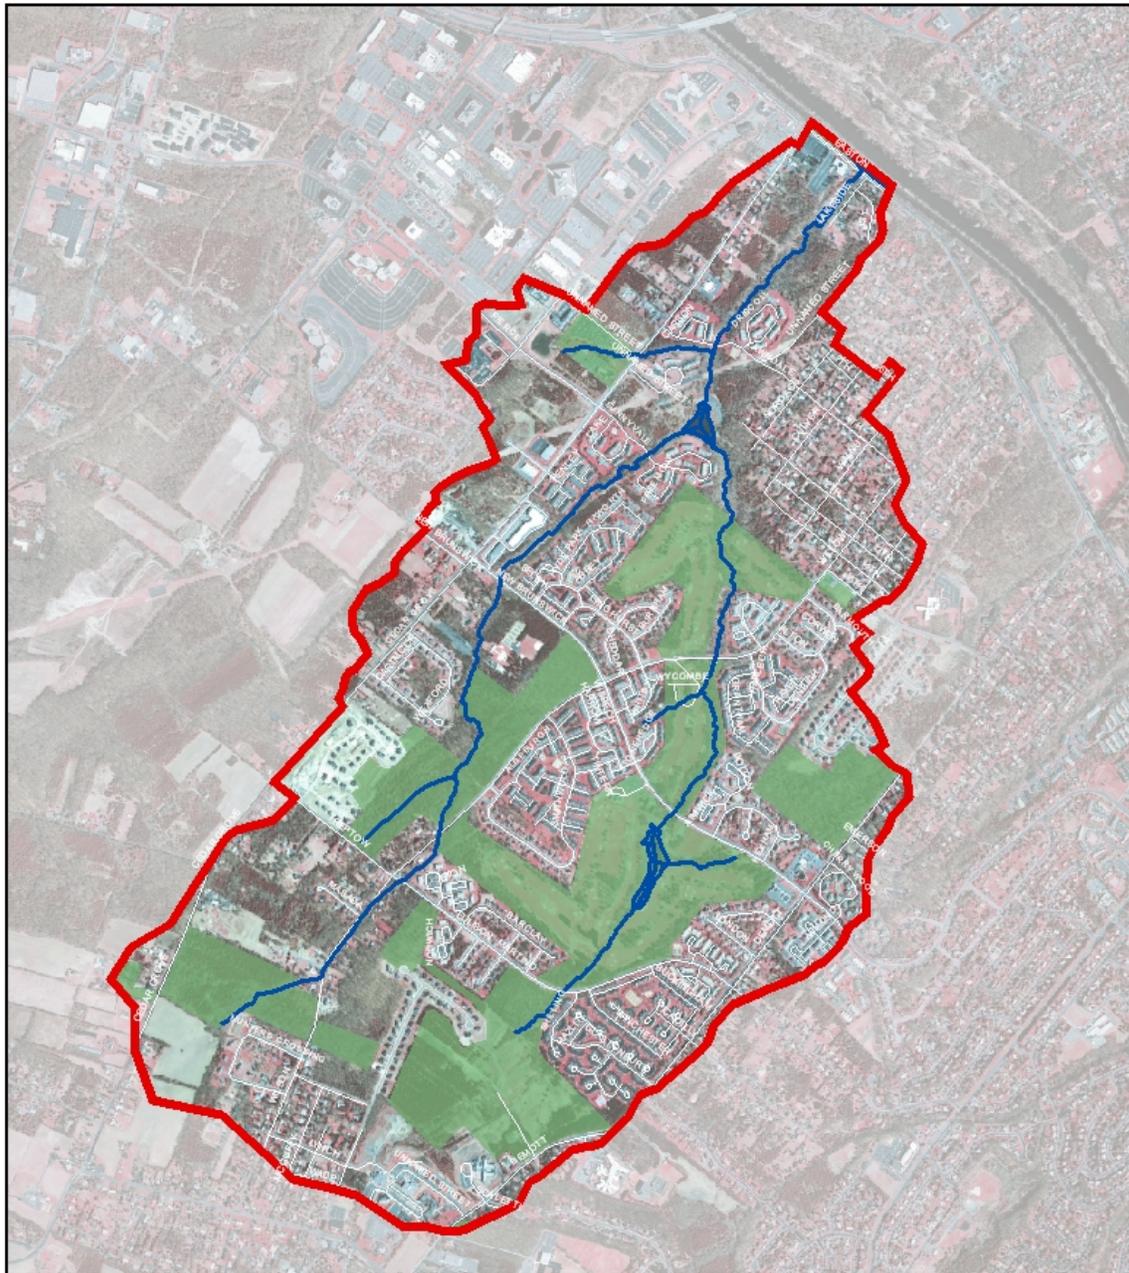
Figure 6: Cedar Grove Brook Watershed Preserved Open Space

The total preserved open space in the Cedar Grove Watershed is 447 acres as of 2009, 25 percent of the total watershed area (**Figure 6**), there is no state owned open space in this watershed and Quail Brook Golf Course is owned by the County, all other open space belongs to Franklin Township. As of 2006, approximately 26 acres of farmland were present in the watershed, primarily along Cedar Grove Lane. These farms are surrounded by residential and other urban development. None are preserved through state or local programs, perhaps due to their small size.

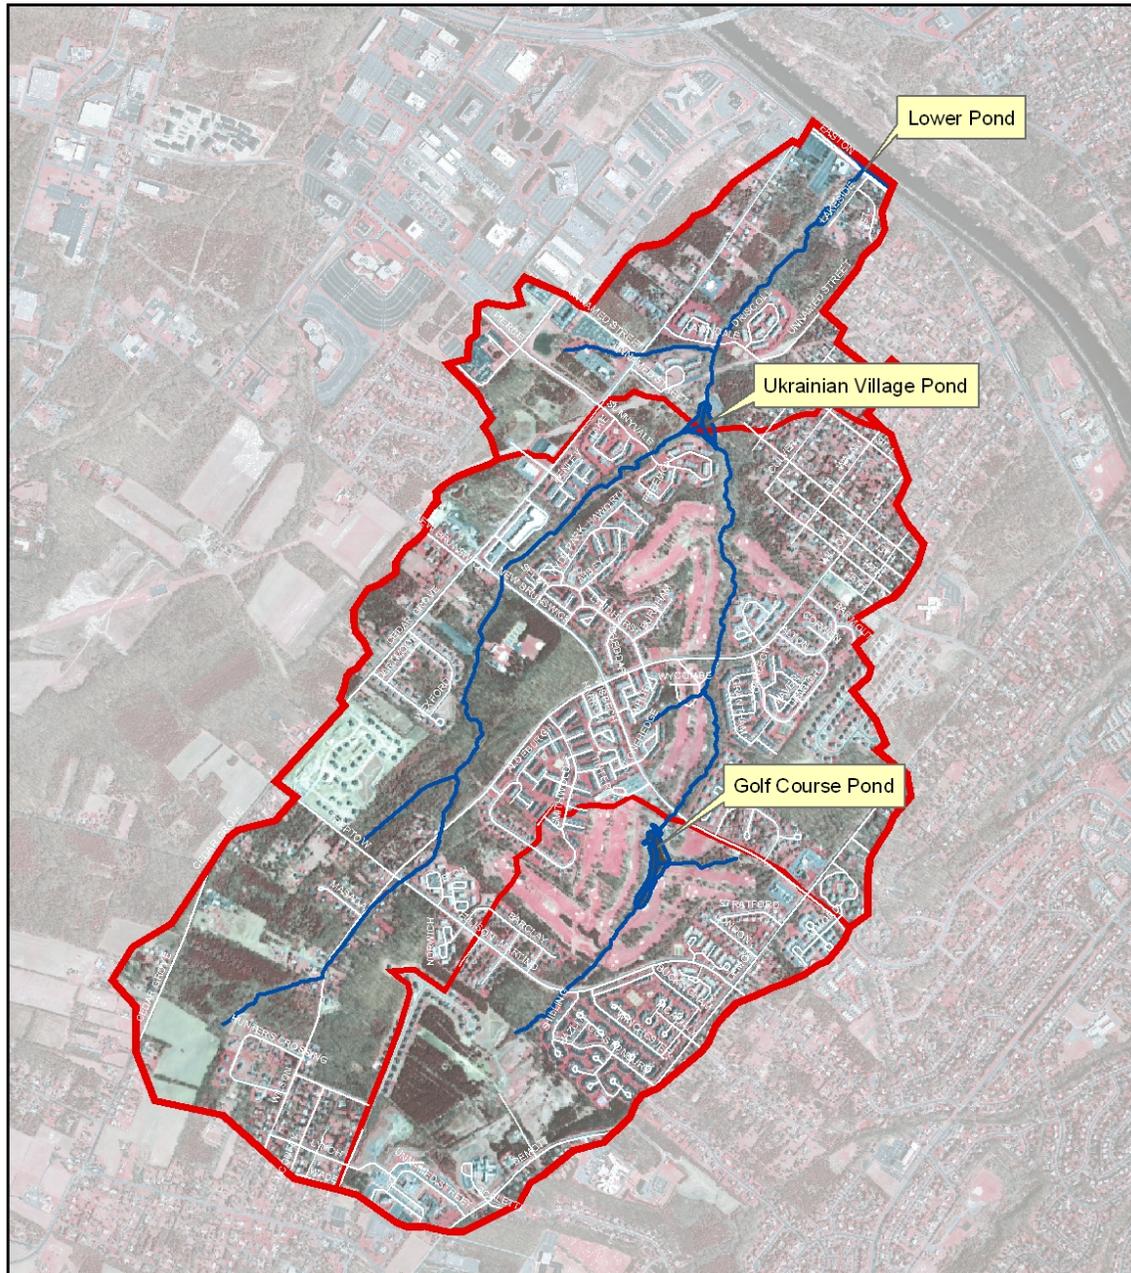
Figure 7: Drainage Area to the Three Ponds

The three existing pond structures in Cedar Grove Brook (Golf Course Pond, Ukrainian Village Pond, and Lower Pond) are providing significant sediment removal such that Cedar Grove Brook is currently discharging far less sediment to the D&R Canal than it would otherwise. However, these same pond structures also act as sediment sources due to the resuspension of accumulated sediment under certain storm conditions. Given the above considerations, the highest

prioritization should be given toward improving the pond structures that already exist in order to optimize their water quality benefits. Each pond feature was evaluated for BMP opportunities, and the outlet structure of each pond was evaluated using long-term WinSLAMM simulations to explore possible modifications to enhance sediment removal.
