Cedar Grove Brook Watershed Restoration and Protection Plan

New Jersey Department of Environmental Protection

**New Jersey Water Supply Authority
74 East Main Street
Somerville, NJ 08876-2312**

July 2011

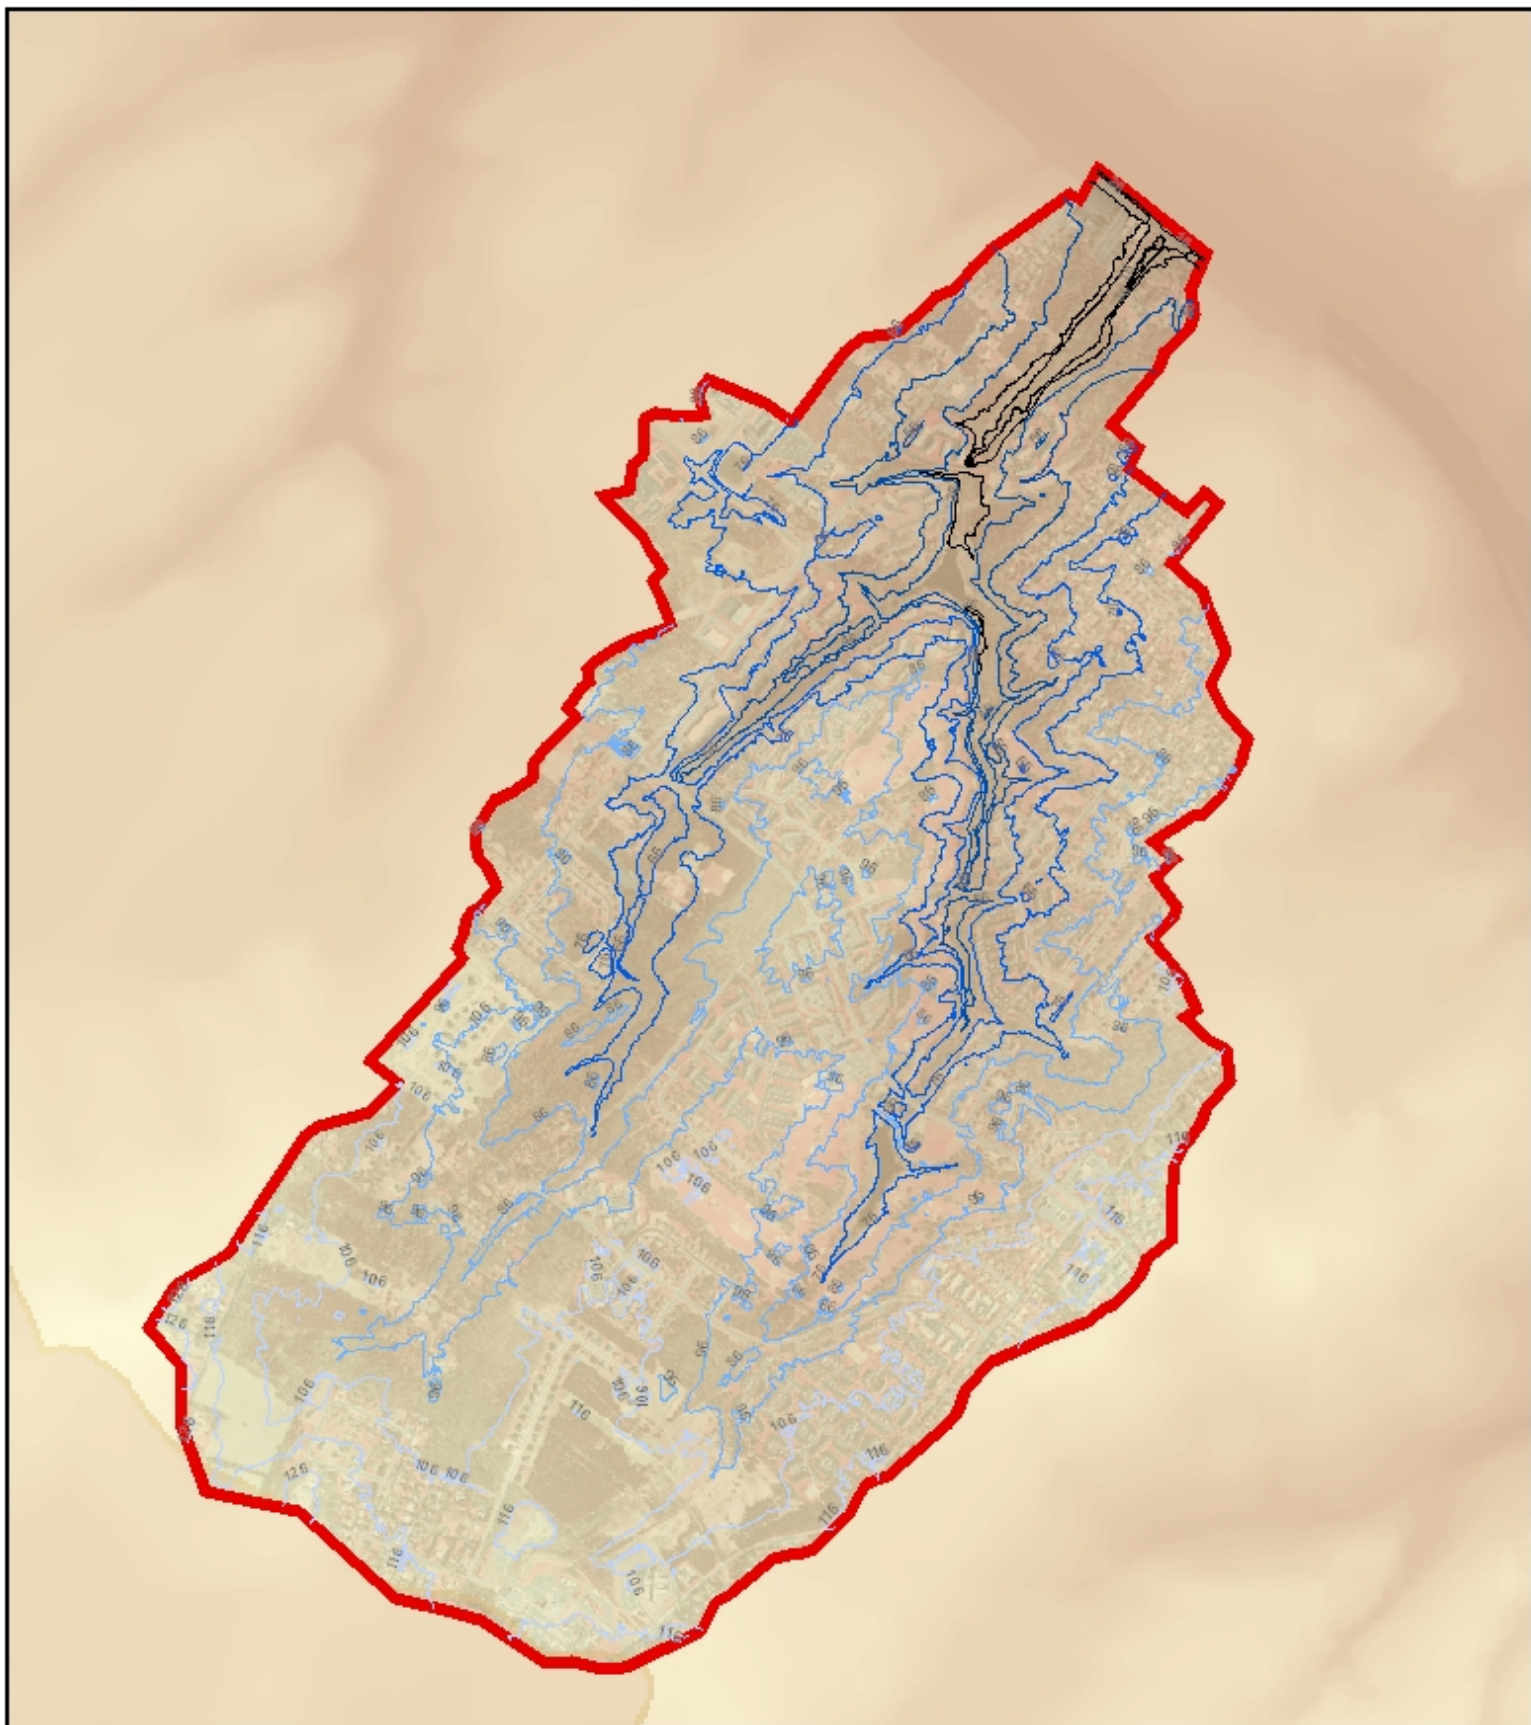
Figure 3. Watershed Contours

The elevation in the watershed ranges from six feet to 132 feet above mean sea level. Contour data was obtained from Franklin Township; Figure 3 presents the contours within the watershed. Inspection of the contours demonstrates the gentle slope of the watershed as well as the steeper sloped areas. Most of the banks along the Cedar Grove Brook are between five and 10 percent slope. As the gradient or percent of slope increases, the velocity of runoff water increases, which increases its erosive power.

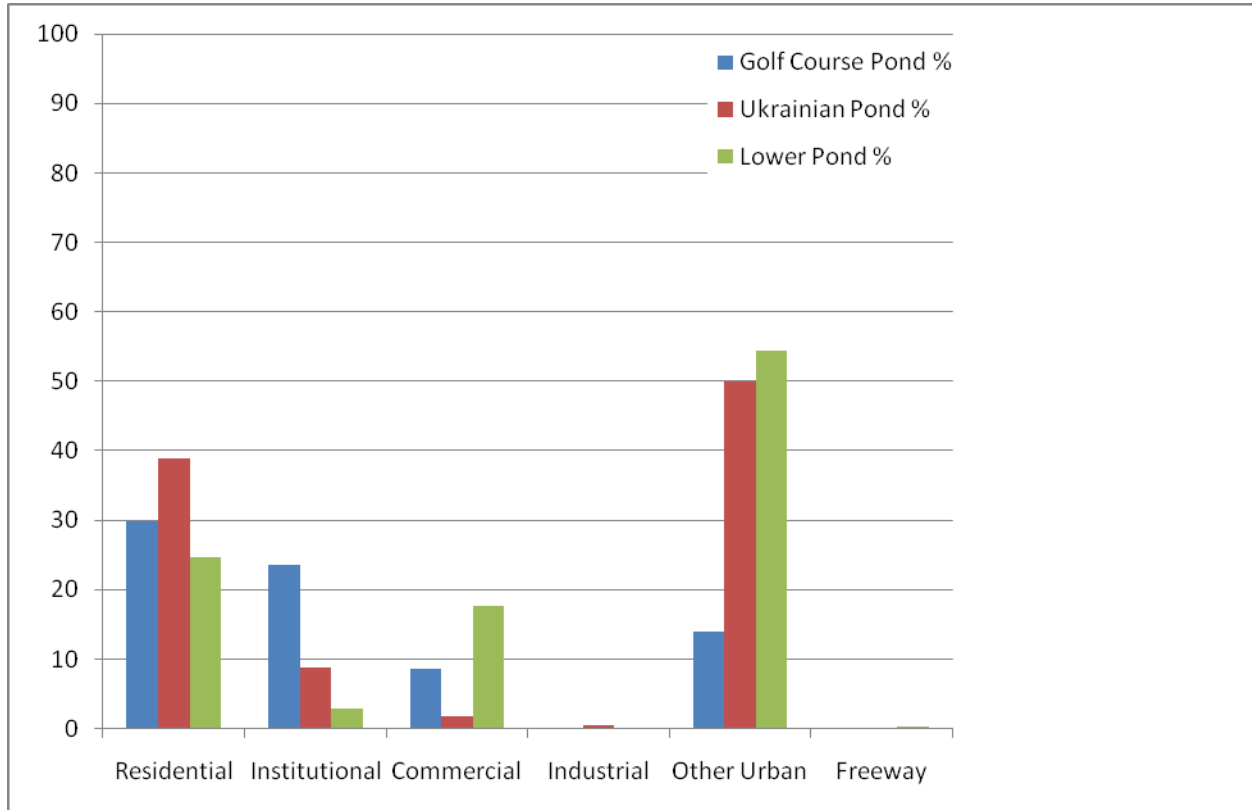
Figure 13. Percentage of Total Particulate Load by Land Use for Three Subwatersheds

The WinSLAMM modeling indicated that the largest sediment loads are typically generated from residential properties (approximately 38%) and the “other urban” land use. The “other urban” land use is the term that WinSLAMM uses for forests, brush/shrub land, wetlands and agriculture. Although vegetation such as lawn and forest is generally considered to be more

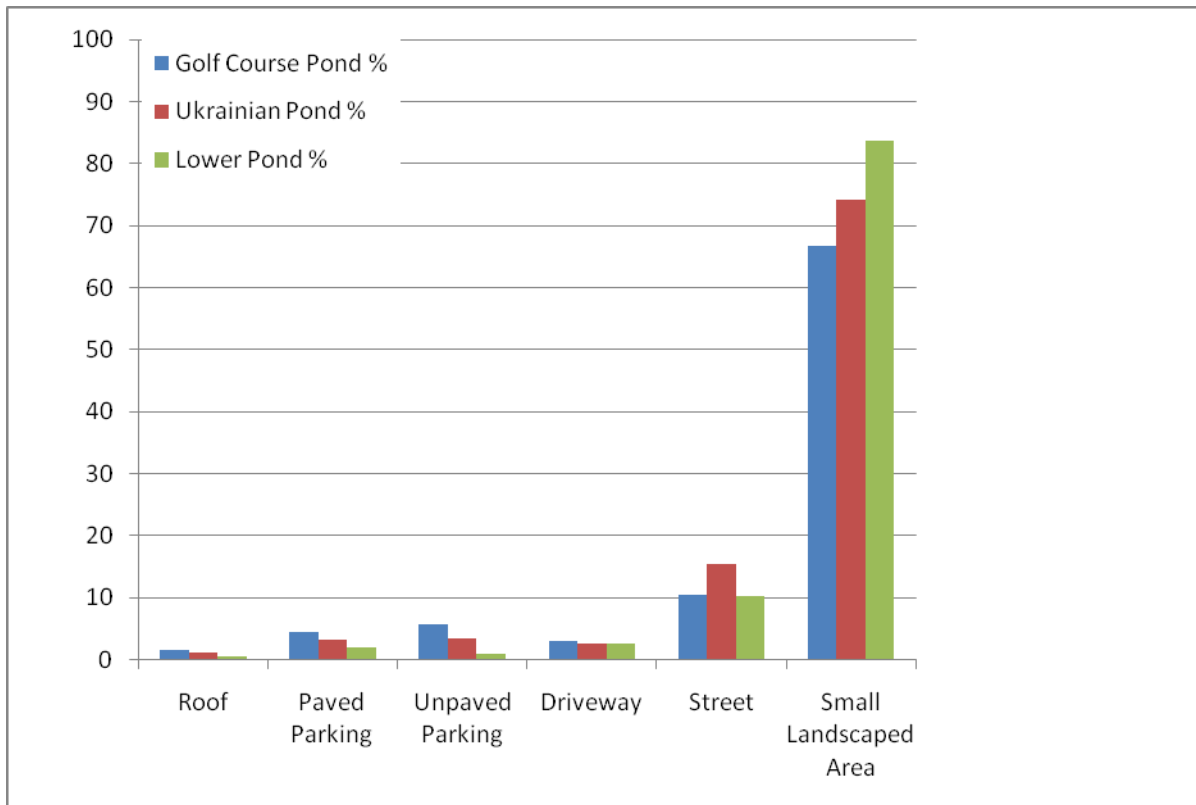
Figure 14. Percentage of Total Particulate Load by Residential Source Area for Three Subwatersheds

In order to better characterize the sediment load from the residential areas, the source areas for that land use were analyzed. WinSLAMM estimates the pollutant load coming from each source area within a land use; for residential land those source areas include roofs, driveways, paved parking areas, unpaved parking areas, streets and small landscaped areas. The results for the three subwatersheds are provided in Figure 14. The WinSLAMM modeling indicated that the majority of the residential sediment load is generated by small landscaped areas, typically lawns and gardens, with some forested areas.

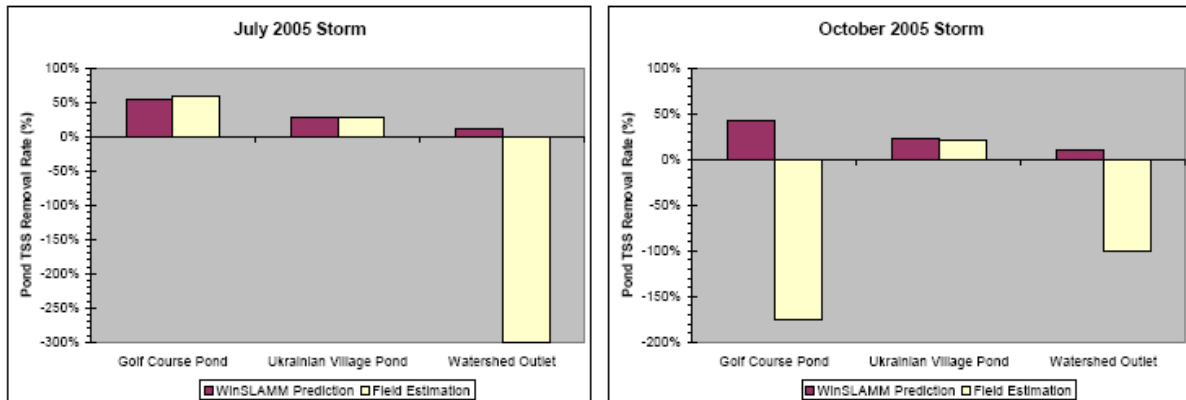
Figure 16. Pond TSS Removal Rate Comparison

Estimates of the observed sediment removal rates during the 2005 storms were based on discrete water quality measurements at the inlet and outlet of each pond. The measured Total Suspended Sediment (TSS) concentrations at the inlet(s) and outlet were flow-weighted based on the estimated flow at the time of sampling in order to calculate Event Mean Concentrations (EMCs) for each storm. Since the total flow in and out of each pond is the same⁷ over the course of each storm, the difference between the EMC at the outlet and the EMC at the inlet represents the pond removal rate. A comparison between the TSS removal rates predicted by WinSLAMM for each storm and the estimated removal rates based on field data is provided in Figure 16.

*Negative "removal" rates indicate that the pond is adding TSS (due to resuspension) during a storm rather than removing it.

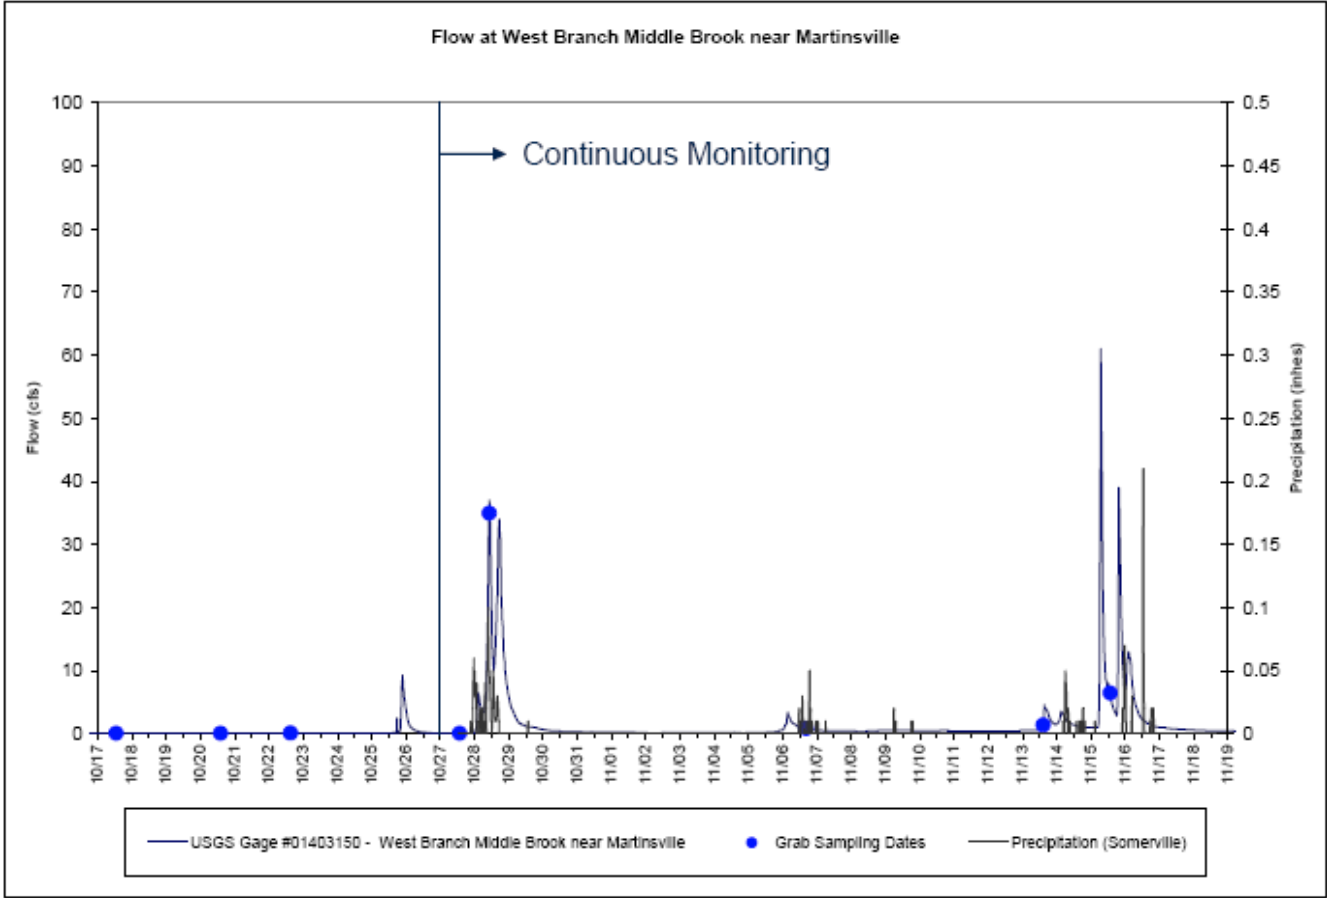
Figure 18. Flow and Precipitation Conditions During Monitoring Period

Flow was characterized using a nearby USGS stream gage (#01403150, West Branch Middle Brook near Martinsville). A small local stream was selected rather than the Canal gage at Port Mercer because the Canal gage is farther away and flow in the Canal is not as responsive to precipitation as a small stream, which would better characterize the response of Canal inlets and tributaries. Precipitation is shown in 15-minute increments based on data from the USGS rain gage in Somerville (#403410074364001). This station is approximately five miles from the sampling locations. The cumulative rainfall amounts for each storm event that occurred during the 2008 continuous monitoring period were as follows: 1.8 inches on 10/28, 0.31 inches on 11/5-11/6, and 1.27 inches on 11/13-11/15.

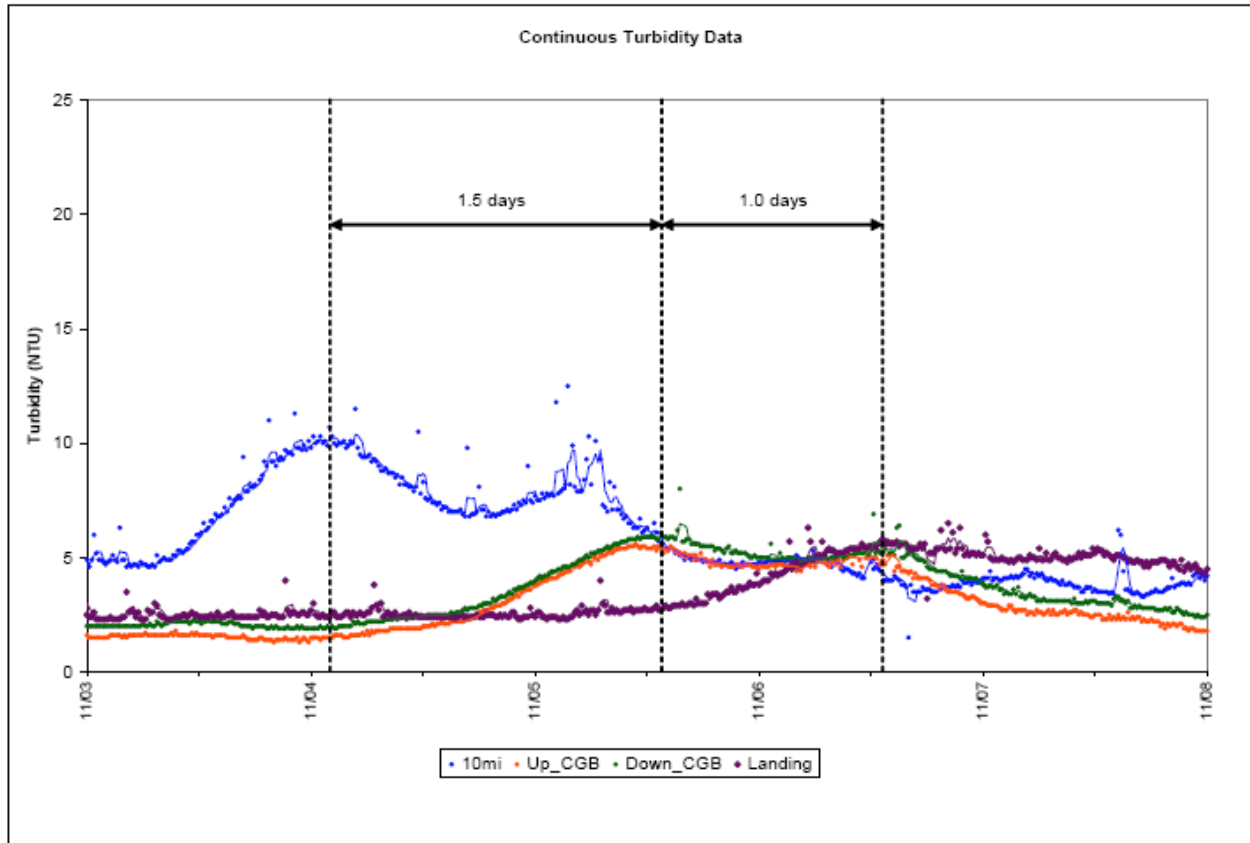
Figure 19. Travel Time of Turbidity in the D&R Canal

Evaluating turbidity monitoring data from the four D&R Canal locations (10mi, Up_CGB, Down_CGB, and Landing) yielded some interesting results. Figure 19 zooms in on a low-flow period from November 3 to 8 and shows that at least some of the turbidity variation observed at the locations upstream and downstream of Cedar Grove Brook, as well as Landing Lane, can be explained simply by downstream propagation of the turbidity signature at the upstream study boundary at Ten Mile Lock. In fact, the turbidity peak at Ten Mile Lock was observed approximately 1.5 days later at the meters upstream and downstream of Cedar Grove Brook, and then again approximately 1 day after that at the downstream study boundary at Landing Lane (near Route 18 spillway). The total travel time of 2.5 days compares favorably with the expected travel time of 2 days 8 hours between Ten Mile Lock and the Route 18 Spillway as reported in the USGS study (USGS, 2001).

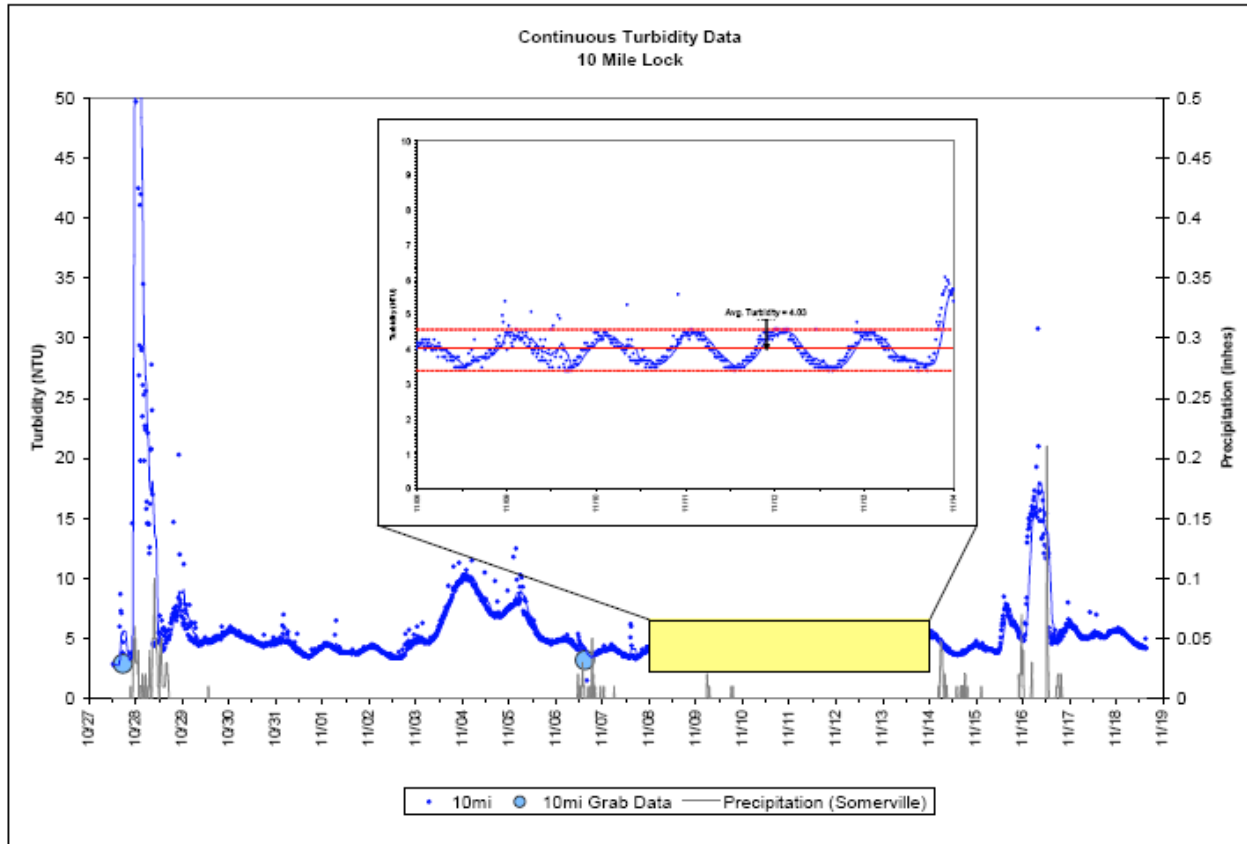
Figure 20. Diurnal Turbidity Variation Observed in the D&R Canal at Ten Mile Lock

The continuous turbidity monitoring yielded one unexpected result: during low-flow periods, the D&R Canal at Ten Mile Lock exhibits clear diurnal turbidity variation (Figure 20) that appears to be natural in origin. The magnitude of the variation – about 1 Nephelometric Turbidity Unit (NTU) – is not significant from a water quality perspective; however, it is consistent and definitely diurnal in nature, with peaks occurring at night (2:00–3:00AM) and troughs occurring in the mid-afternoon. Furthermore, as shown in Figure 20, the diurnal turbidity pattern exhibited at Ten Mile Lock is propagated downstream as well.

dissolved oxygen). The results of the continuous turbidity monitoring suggest that turbidity varies diurnally under some circumstances as well. Possible causes of diurnal variation include changes in flow, benthic macroinvertebrates activity, and temperature-related physical factors such as viscosity and sorption rates. The meter at Ten Mile Lock was deployed downstream of the lock itself, closer to the footbridge, and well past the area of turbulence associated with the lock. The smooth and consistent pattern suggests a natural diurnal phenomenon.

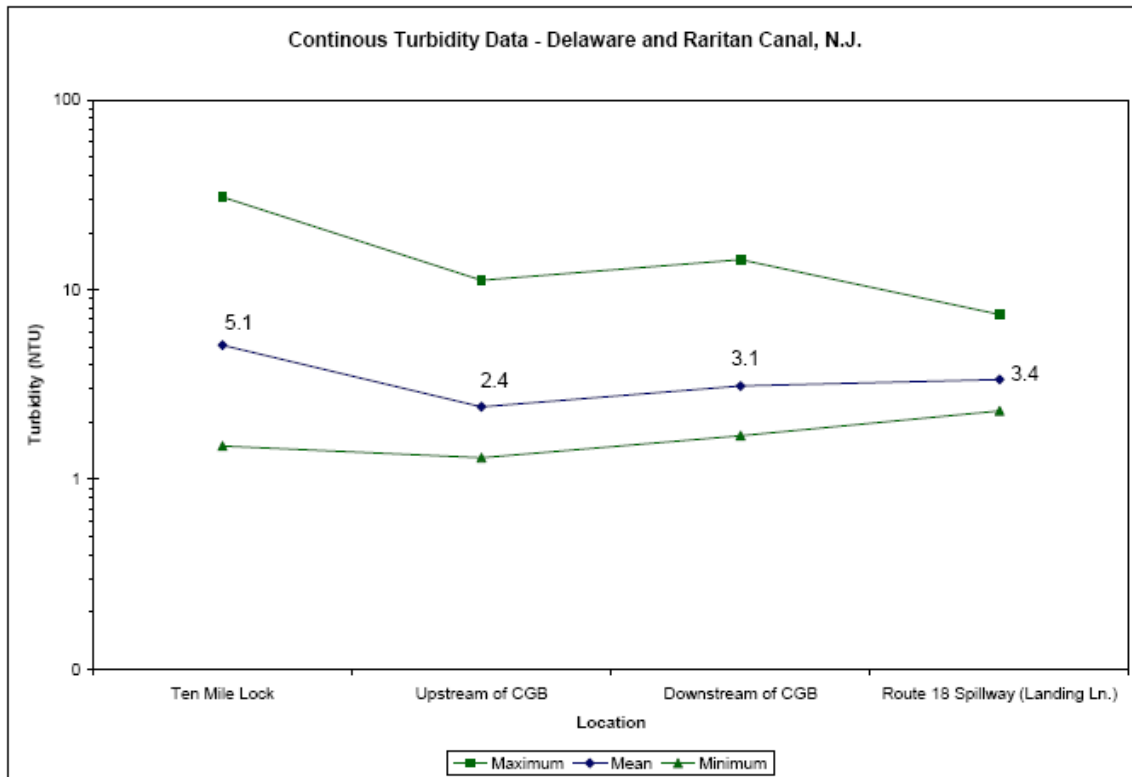
Figure 21. Turbidity Changes in the D&R Canal from Ten Mile Lock to the Route 18 Spillway

The maximum, mean, and minimum turbidity values from the continuous turbidity data collected at the four D&R Canal locations are shown in Figure 21. The format and results are similar to that provided in the 2001 USGS study and can be compared directly. The USGS study was performed over a longer period of time (16 months), but did not include any turbidity measurements between Ten Mile Lock and the Route 18 Spillway. In terms of overall magnitude, the USGS average turbidity was approximately 9 NTU at Ten Mile Lock and the Route 18 Spillway locations, while the observed means during the 3-week survey in 2008 were 5.1 and 3.4 NTU at Ten Mile Lock and the Route 18 Spillway, respectively. The lower magnitude of the average can be attributed to the shorter time frame that included fewer major storms with high turbidity peaks. In fact, the highest maximum turbidity observed during the three-week survey in 2008 was 31 NTU at Ten Mile Lock, whereas the USGS long-term monitoring reported a maximum turbidity over 200 NTU at the same location. It is not surprising

that the maximum recorded turbidity over a 16-month period would be substantially larger than that observed over a 3-month period.

More importantly, the overall trends between Ten Mile Lock and the Route 18 Spillway were similar in both studies. The maximum recorded turbidity was significantly higher at Ten Mile Lock than at the Route 18 Spillway during both studies. Furthermore, the minimum recorded turbidity was very similar at both Ten Mile Lock and Route 18 Spillway locations during both studies. While the average turbidity during the 3-week survey in 2008 decreased by 1.7 NTU between the Ten Mile Lock and Route 18 Spillway locations (compared to only 0.1 NTU during the long term study by USGS), the observed average decrease was still much less than the 4 NTU that might be expected based on turbidity settling in other segments of the Canal (USGS, 2001). The turbidity trends at the Ten Mile Lock and Route 18 Spillway locations are similar between the two studies. It is evident from Figure 22 that Cedar Grove Brook does increase turbidity in the D&R Canal – maximum, average, and minimum turbidity all increase between the Canal monitoring locations upstream and downstream of the Cedar Grove Brook discharge point into the Canal; however, the magnitude of the increase in maximum, minimum, and average turbidity does not appear to be significant from a water quality perspective; for example, the maximum turbidity increased from 11 to 14 NTU due to the impact of Cedar Grove Brook. It is also worth noting that turbidity continues to increase between Cedar Grove Brook and the Route 18 Spillway, indicating that there may be another important discharge to the Canal in that segment.

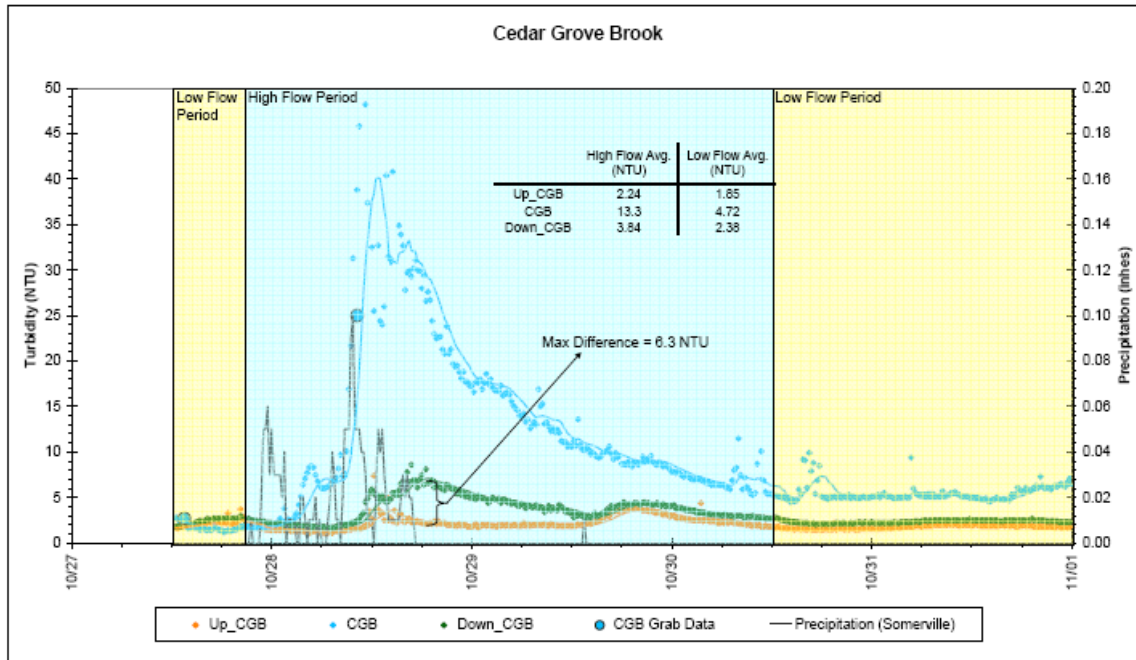
Figure 22. Turbidity Impact During High and Low Flow Periods

In order to better assess the impact of Cedar Grove Brook on turbidity in the D&R Canal, it is helpful to zoom in on high and low flow periods. Figure 22 shows turbidity in the Canal upstream and downstream of Cedar Grove Brook, as well as in Cedar Grove Brook itself, during and after a storm event. Precipitation is also shown (in 15-minute intervals) along with grab turbidity sampling results that confirm the validity of the continuous turbidity results.

During the storm event, turbidity in Cedar Grove Brook peaked at over 40 NTU, whereas the turbidity in the Canal remained below 10 NTU. The maximum increase in turbidity in the Canal downstream of Cedar Grove Brook (e.g. difference between Up_CGB and down_CGB) was 6.3 NTU; furthermore, the impact of Cedar Grove Brook on the Canal was transient, with turbidity returning to pre-storm levels in about one day.

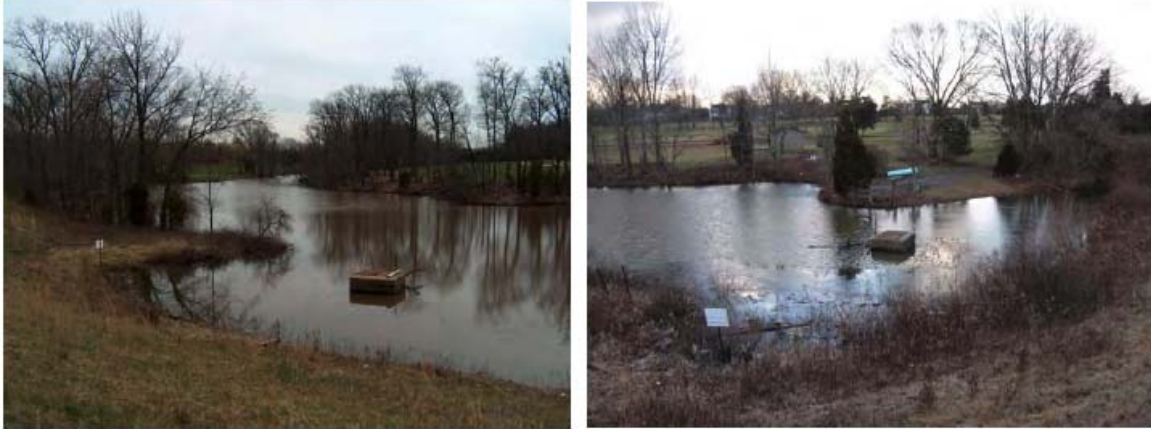
Figure 25. Golf Course Pond

The most upstream of the pond features in Cedar Grove Brook is the Golf Course Pond (Figure 25).

Two potential improvements to the Golf Course Pond were identified to increase the sediment removal rate and thereby reduce the sediment load to the downstream portion of Cedar Grove Brook:

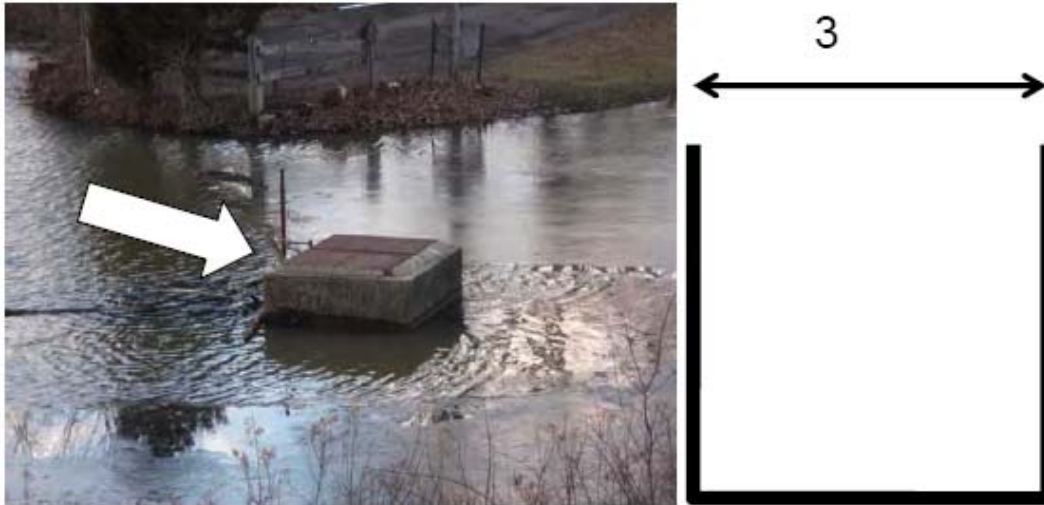
Figure 26. Golf Course Pond - Existing Outlet Structure

The existing outlet structure is a 3-foot long weir in the upstream side of an outlet box (Figure 26). The WinSLAMM simulation predicts an overall sediment removal rate of approximately 50%. Because the weir faces “upstream,” much of the pond volume appears to be short-circuited, which reduces the expected sediment removal rate.

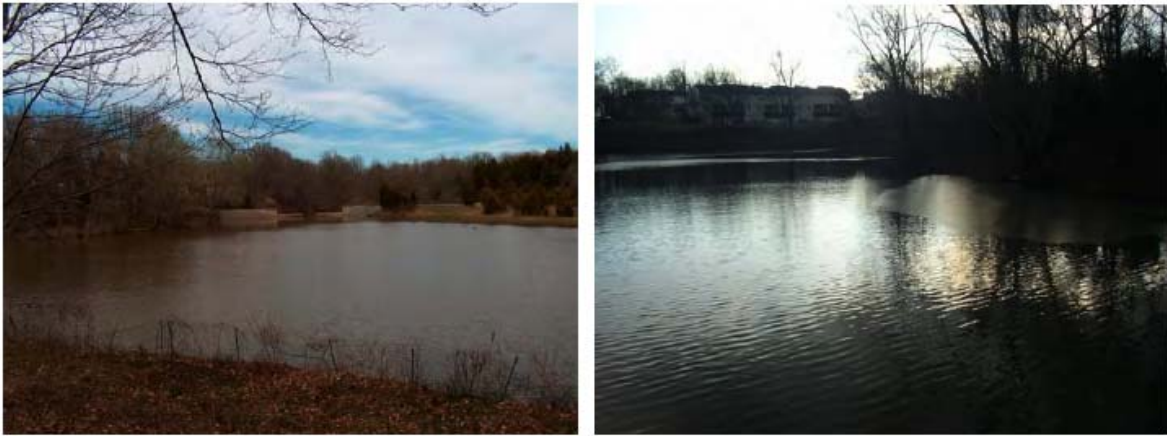
Figure 29. Ukrainian Village Pond

The Ukrainian Village Pond (Figure 29) is downstream of the Golf Course Pond close to the center of the Cedar Grove Brook watershed. The Ukrainian Village Pond is an impoundment with two tributary inlets that discharges to Cedar Grove Brook. A relatively simple modification to the outlet structure is proposed to increase the sediment removal rate and thereby reduce the sediment load to the downstream portion of Cedar Grove Brook.

The existing outlet structure for the Ukrainian Village Pond is a 1-foot square weir within a larger 11-foot weir (Figure 30). According to the WinSLAMM simulations performed for the Ukrainian Village Pond, the existing overall sediment removal rate is approximately 33%.

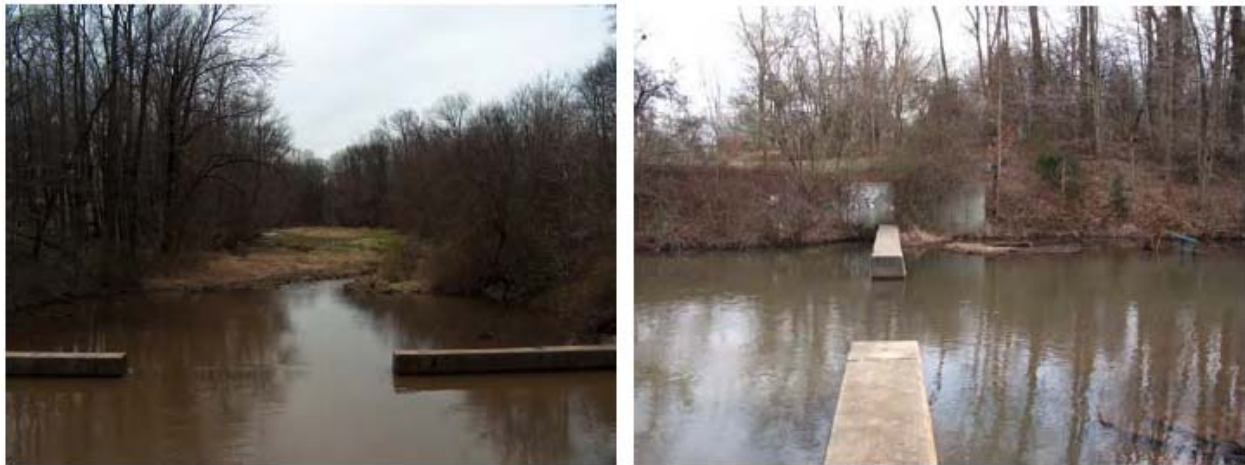
Figure 33. Lower Pond - Cedar Grove Brook Outlet

The outlet of Cedar Grove Brook (called “Lower Pond” for the purposes of this study) is impounded slightly by a dam structure just upstream of the Easton Avenue bridge with a weir that is generally submerged at the crest (Figure 33). Despite the dam structure, the outlet of Cedar Grove would not likely be identified by the casual observer as a pond under current conditions; one can see the bottom less than one foot below the weir crest. Nevertheless, the designation “Lower Pond” was adopted to reflect what this feature would become after the recommended restoration is complete. The reason is that the conceptual improvement identified for the outlet of Cedar Grove Brook to reduce the sediment load to the D&R Canal is a significant modification to the outlet structure. This modification would increase the height of the weir crest, resulting in a permanent pool of water 5 to 7 feet deep, thereby making it a more easily recognized pond feature.

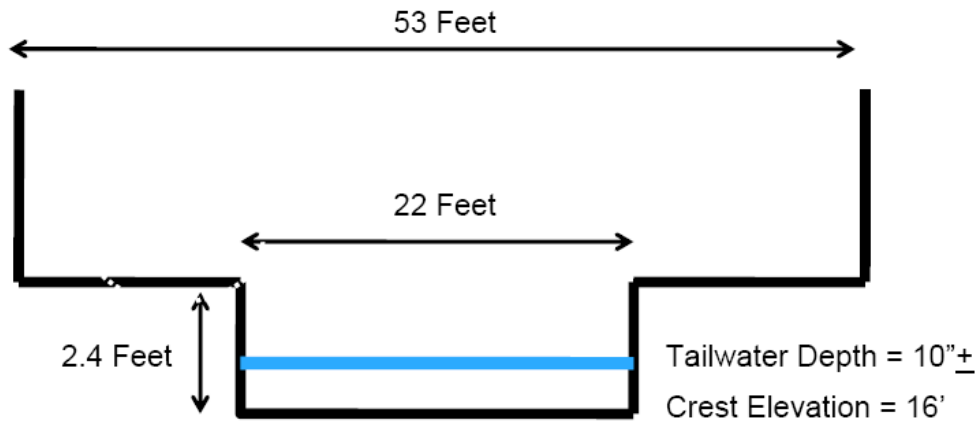
Figure 34. Lower Pond - Existing Outlet Structure

A diagram of the existing outlet structure is shown in Figure 34. The current structure is not very useful from the standpoint of sediment removal. The WinSLAMM simulations indicate that the existing structure might be expected to remove approximately 3% of the sediment that reaches the outlet of Cedar Grove Brook. The WinSLAMM simulation does not account for the fact that the weir crest is generally submerged by Canal water, nor does it account for the resuspension of accumulated sediment. It is very likely that the outlet of Cedar Grove Brook provides a net source of sediments to the D&R Canal. The outlet structure could be improved substantially by increasing the elevation of the crest and decreasing the width of the smallest weir.

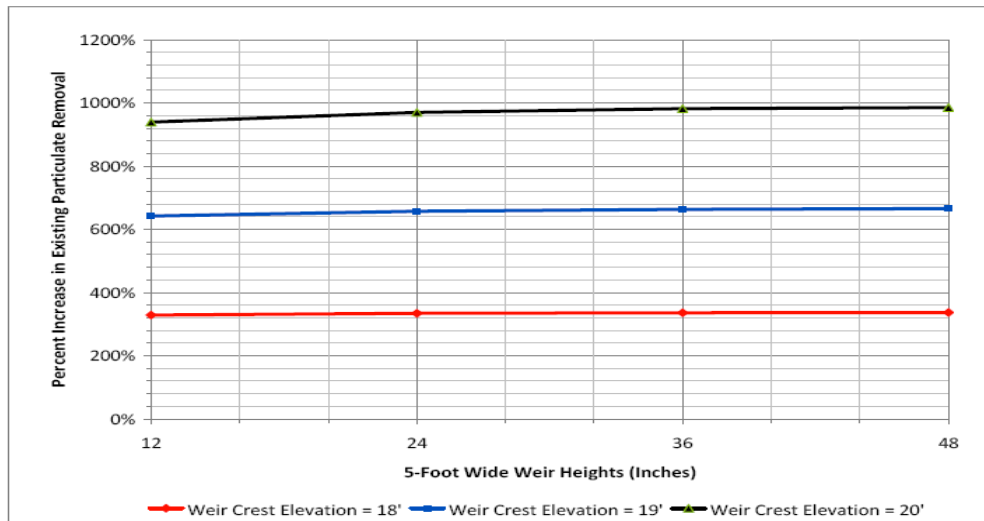
Figure 37. Lower Pond - Percent Change in Particulate Removal

The WinSLAMM model indicated that sediment removal is relatively insensitive to weir height at this location (figure 37). A 5-foot weir at a higher crest elevation will significantly improve the sediment removal rate of the outlet structure. Increasing the crest elevation will provide the most benefit of the elevation options explored, increasing the overall sediment removal rate to approximately 30%. This does not account for the fact that the weir crest would no longer be submerged by Canal water, or the additional benefit of reduced sediment resuspension.

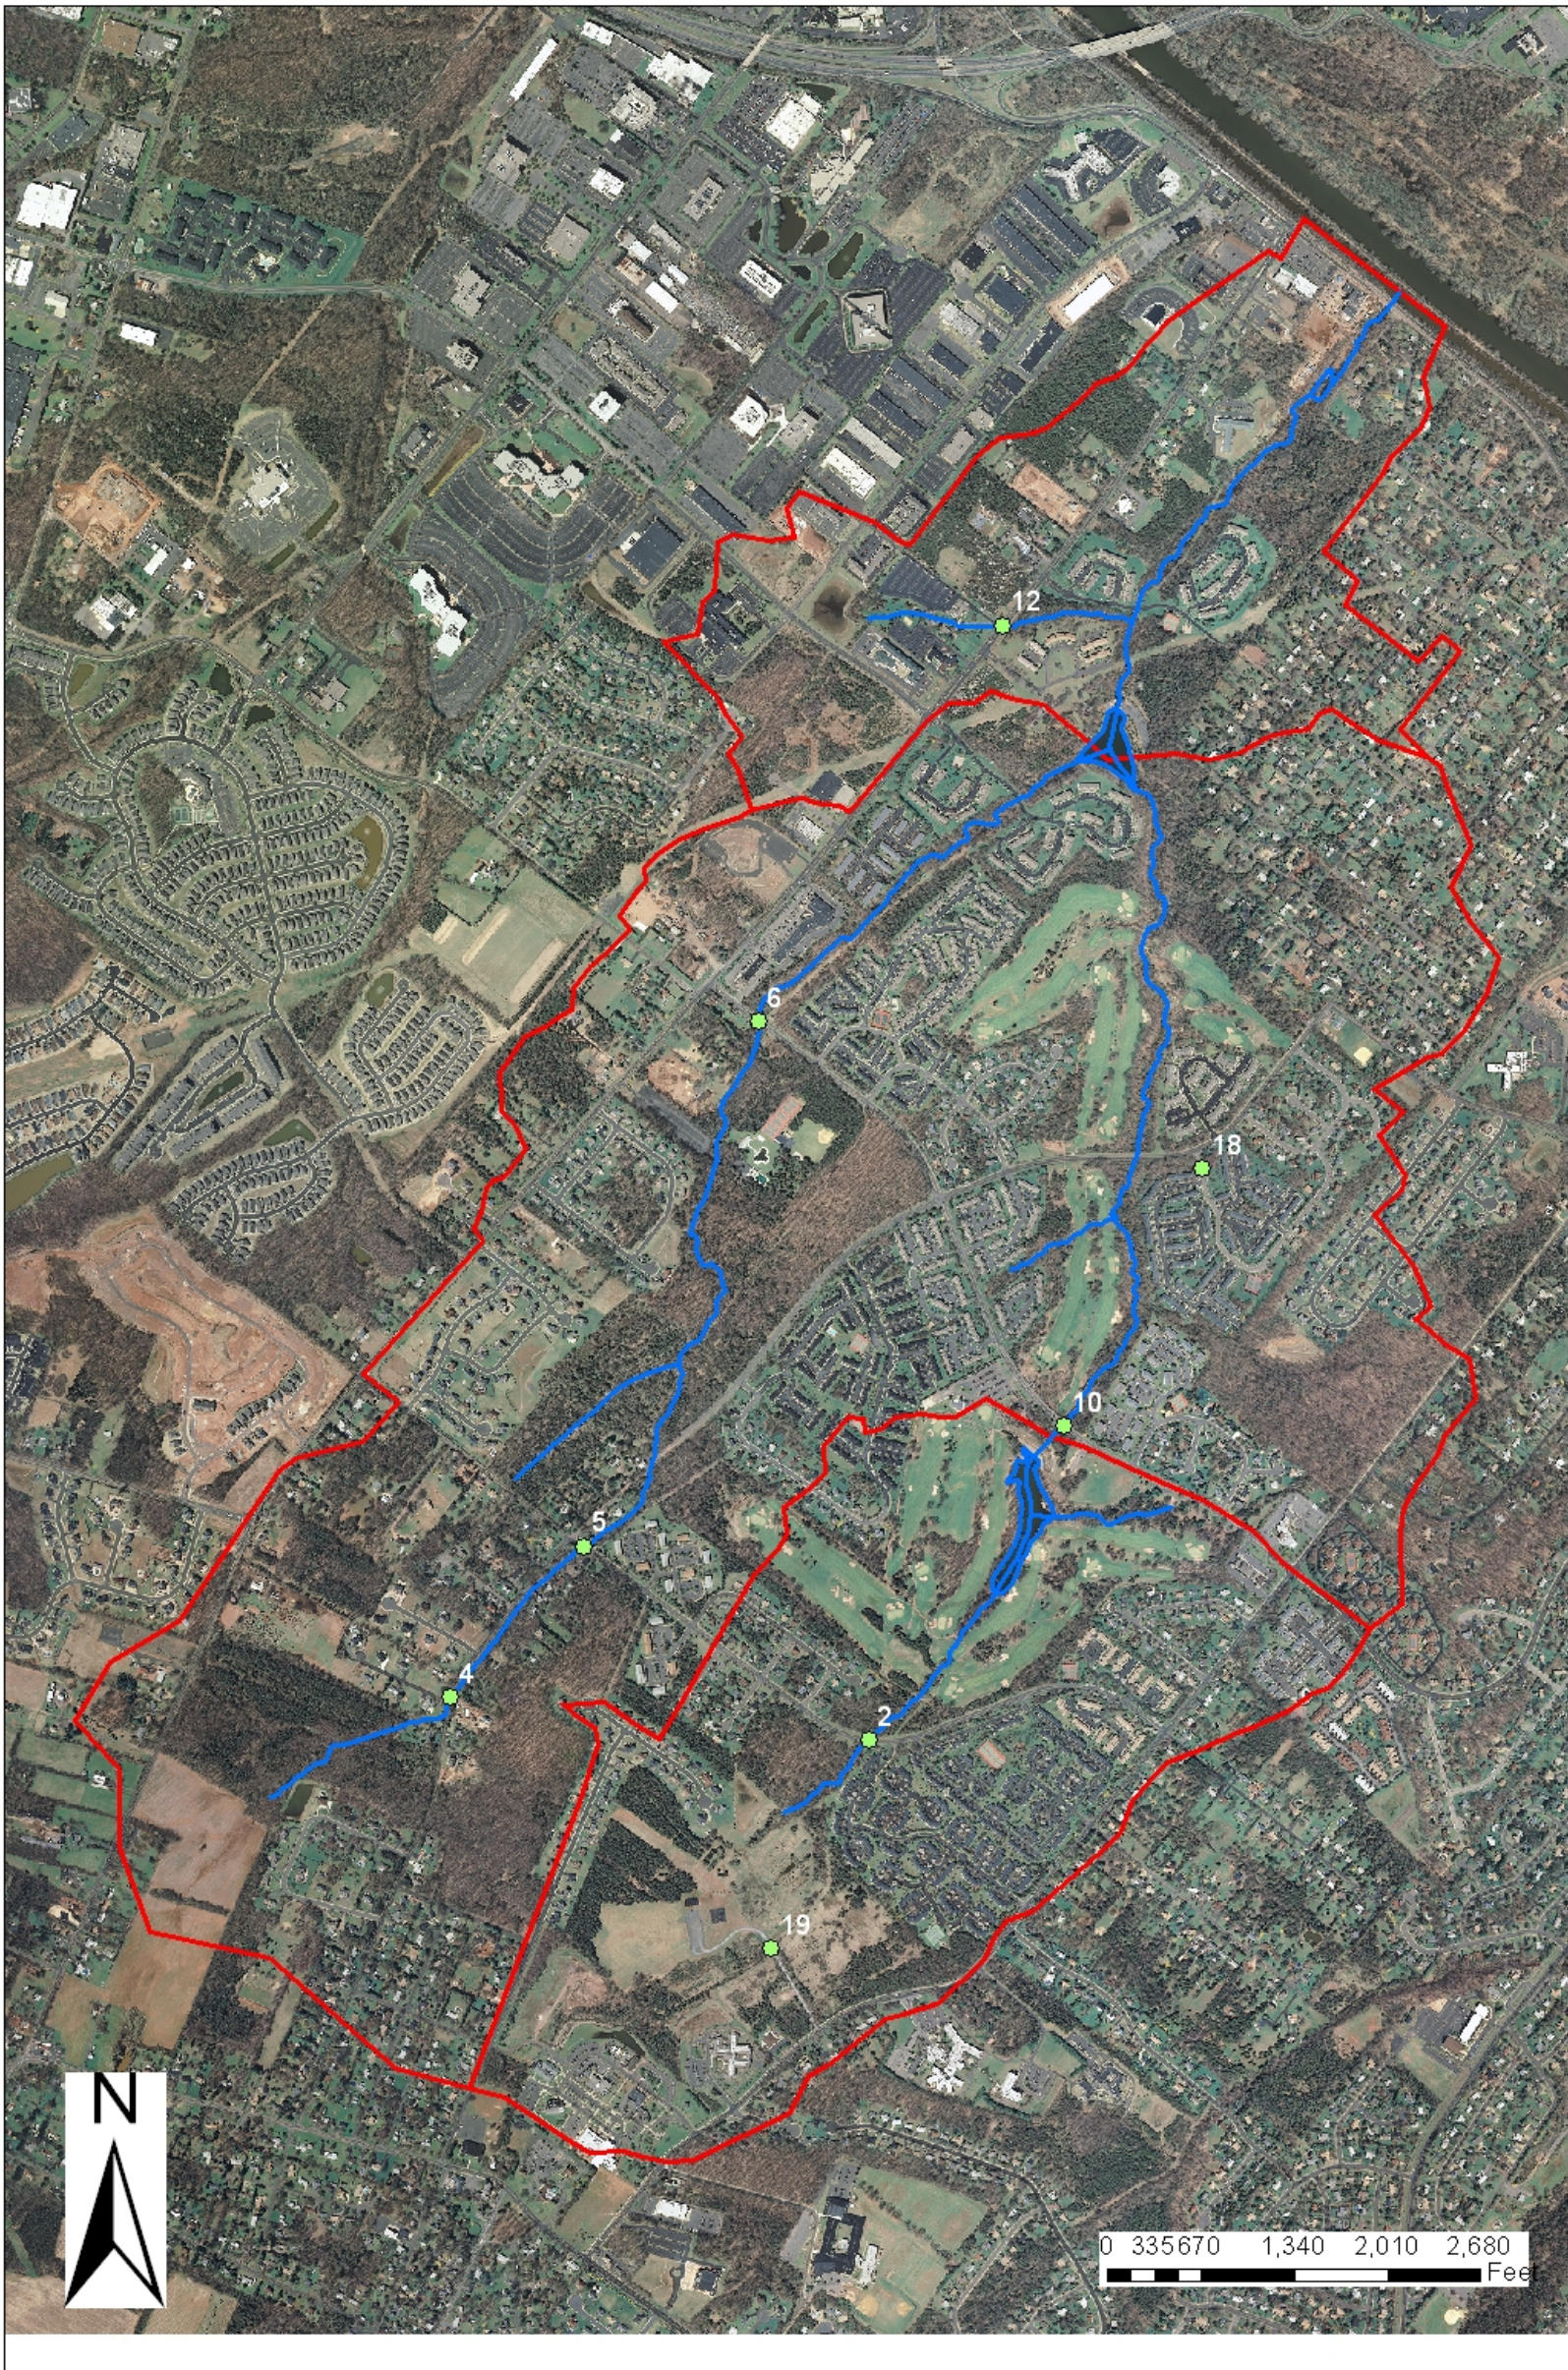
Figure 38. Potential Riparian Restoration Sites

As detailed in Table 15 and Figure 38, eight sites were identified for riparian buffer restoration. The recommendations were developed based on the road crossing inventory and the stream visual assessments. Riparian buffer restoration may include forest and herbaceous plantings. Sediment removal rates and cost estimates were not detailed for each site, as those factors will be dependent on the width of the buffer and the plant species that are selected.

A detailed planting plan must be developed for each site prior to implementation. In addition, permitting may be required for some projects.
