Cedar Grove Brook Watershed Restoration and Protection Plan

New Jersey Department of Environmental Protection

**New Jersey Water Supply Authority
74 East Main Street
Somerville, NJ 08876-2312**

July 2011

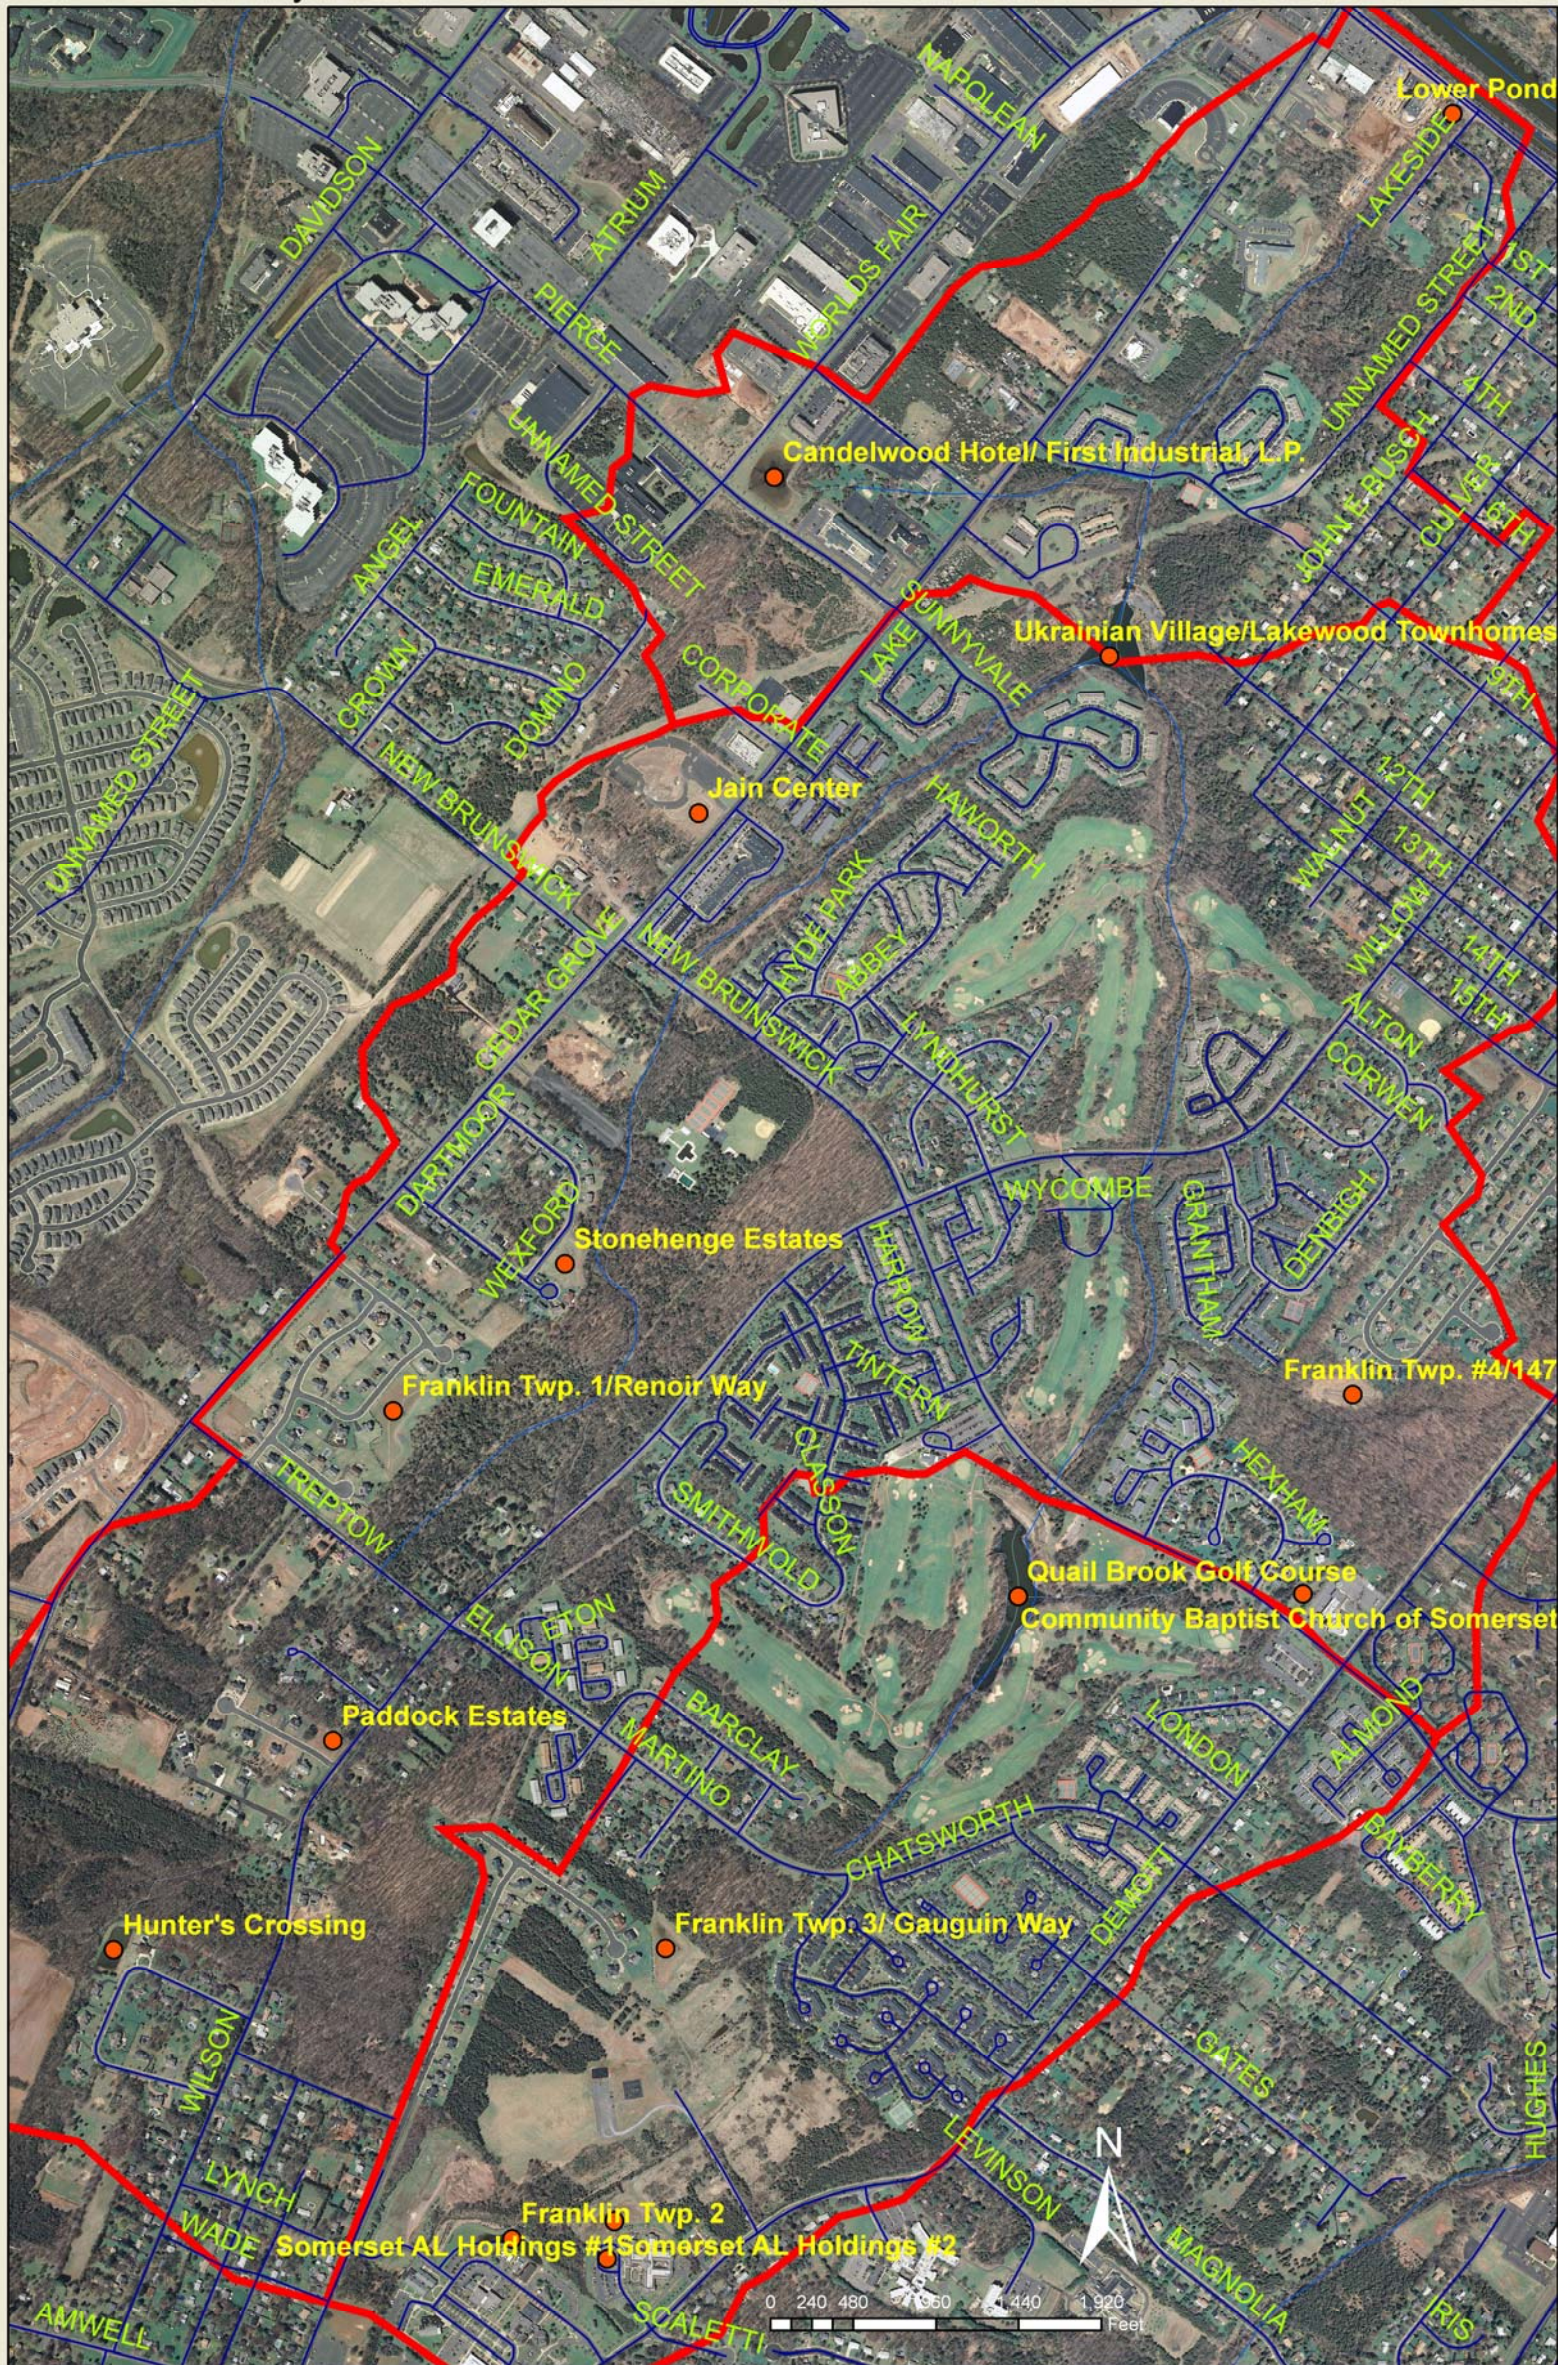
Figure 39. Key Stormwater Basins

GIS layers identifying stormwater basins in the watershed were obtained from Somerset County and the Somerset-Union Soil Conservation District. A total of 15 basins were identified from the GIS layer and field observations. There may be other basins within the watershed that were not identified in this effort. General observations are included in Table 9, locations are shown in Figure 39.

Many stormwater basins were designed with concrete low flow channels to force water to move quickly through the basin during smaller storm events. These channels can act as an obstacle to water quality treatment in those basins. Concrete low flow channels should, in most instances, be removed and replaced with vegetation or other stabilizing material. Most basins were also constructed with turf grass, which does not promote infiltration. By replacing turf grass with native grasses or other low maintenance vegetation, maintenance costs can be reduced (by reducing mowing needs) and infiltration can be increased.

As with the riparian restoration projects, specific removal rates and costs for retrofit were not developed for these projects. Additional information, including detailed review of the existing design and the contributing drainage area for each basin must be developed in order to provide those estimates.
