Lockatong and Wickecheoke Creek Watersheds Restoration and Protection Plan

**Funded, in part, by an NJDEP 319(h) grant
Contract: RP05-082**

**New Jersey Water Supply Authority
Watershed Protection Programs Unit**

June 2009

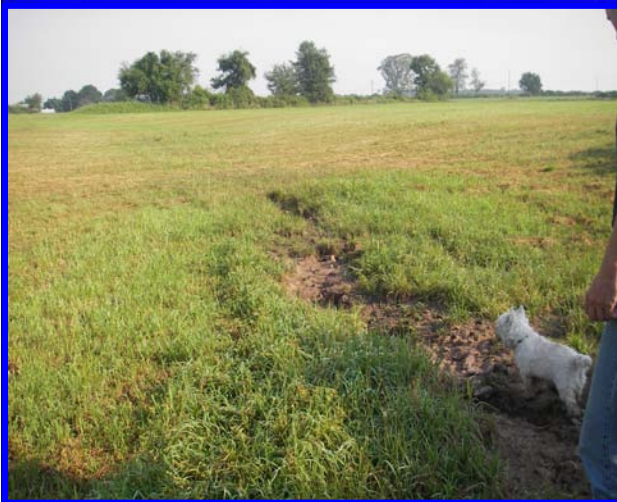
Photo 1. Perimeter erosion from concentrating field drainage.

Stormwater drainage from non-erosive agricultural and athletic fields can accumulate along the perimeter of the subject area and can quickly change from sheet flow (laminar) to concentrated channelized flow (turbulent). **Photos 1 and 2** show the onset and possible result of this unmanaged flow condition at an agricultural site in Delaware Township.

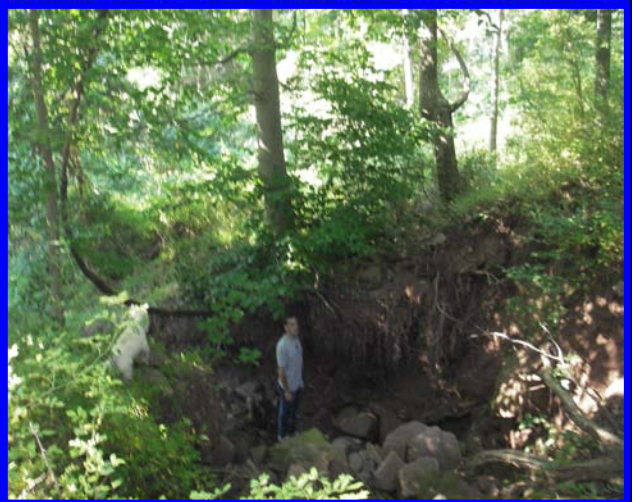
Photo 2. Effect of accumulated field runoff on a drainage channel.

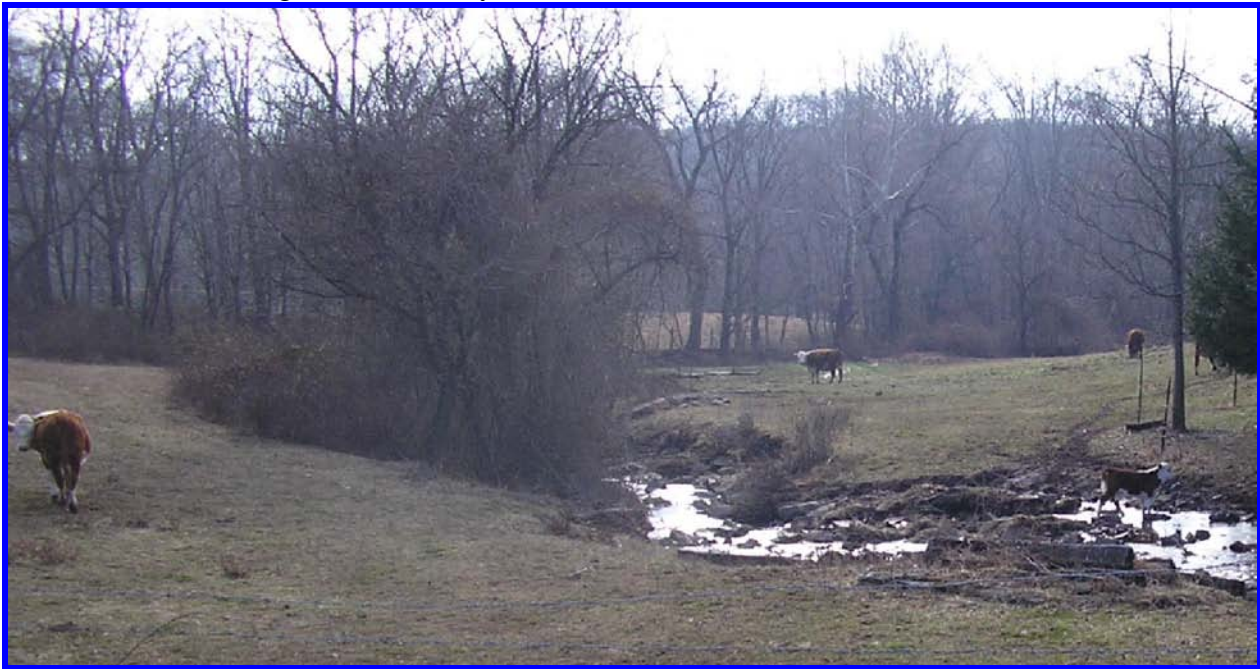
Photo 3. Livestock egress to tributary of Wickecheoke Creek.

There has been more than a 50 percent reduction in the numbers of beef cattle, dairy, sheep, and swine animals in the watershed municipalities from 1983 thru 2004. Numbers of equine have remained steady. Due to the reduction in numbers of animals, this source of erosion and nutrient production was not considered to be a priority unless the animals have direct access to the stream where excrement and activity would severely degrade the aquatic habitat and water quality. **Photos 3 and 4** show cattle and sheep access on a tributary to the Wickecheoke Creek and a tributary to the Lockatong Creek, respectively.

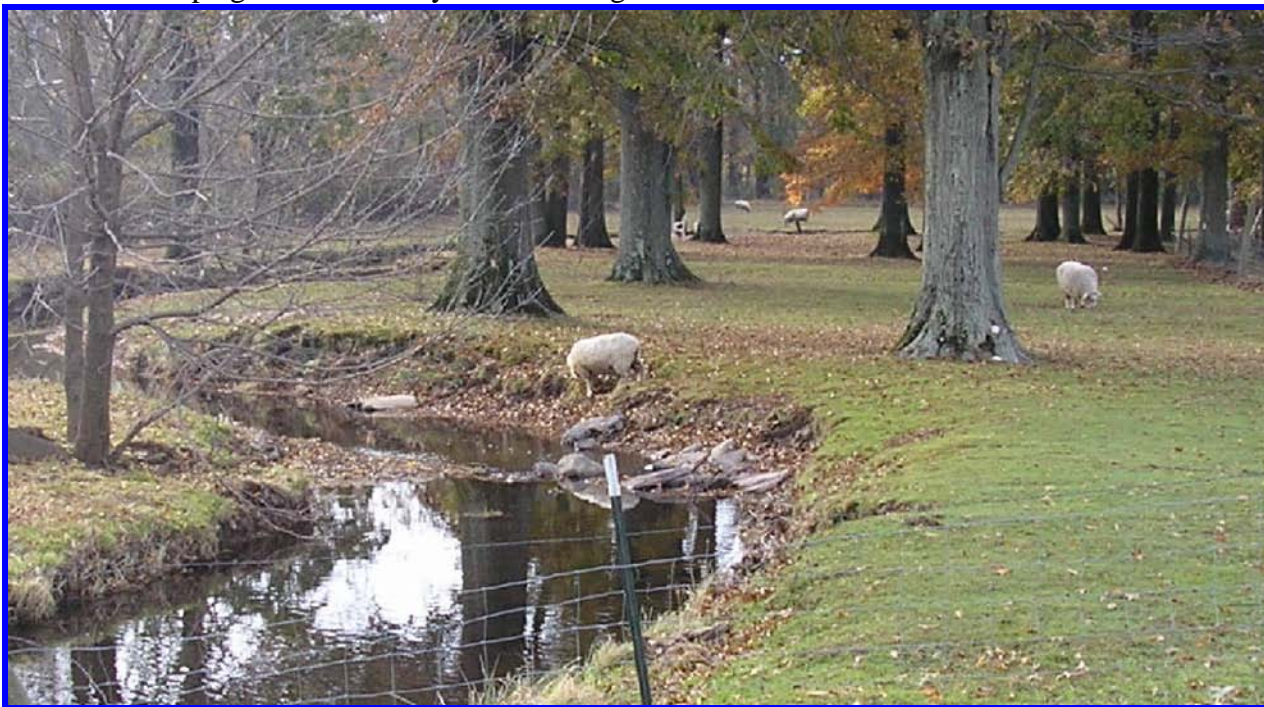
Photo 4. Sheep egress to tributary of Lockatong Creek.

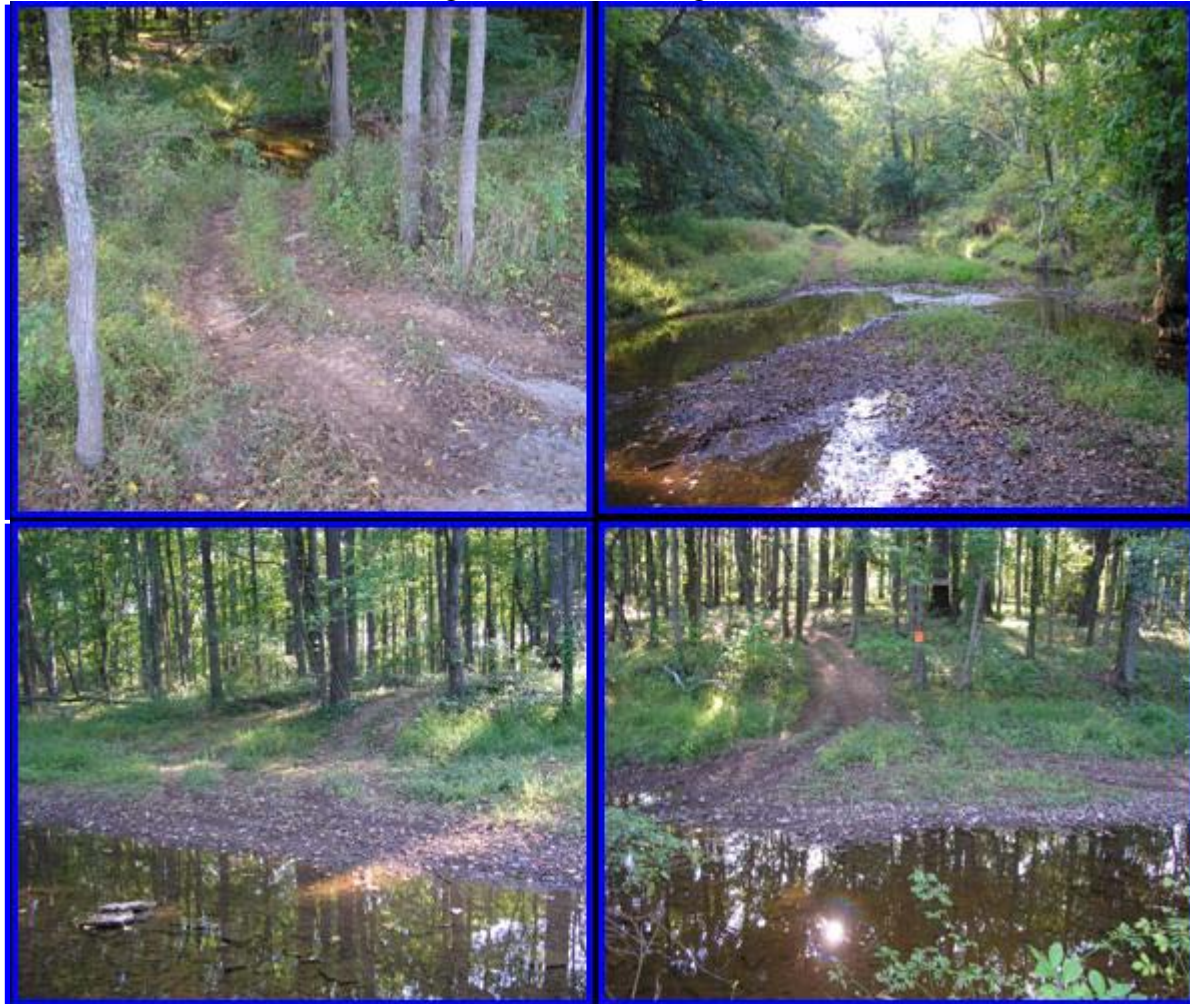
Photos 5 thru 8. ATV trails along, and in, Lockatong Creek.

Photos 5 thru 8 show some of the indications that ATV activity has begun to substantially degrade the aquatic habitat and water quality. These photos were taken at locations within 200 feet of the Union Road bridge at Kingwood Park. Walking paths in public parks are becoming access roads to sections of the streams. More than 45 tons of sediment per year is likely from erosion that has been observed at accessible locations.

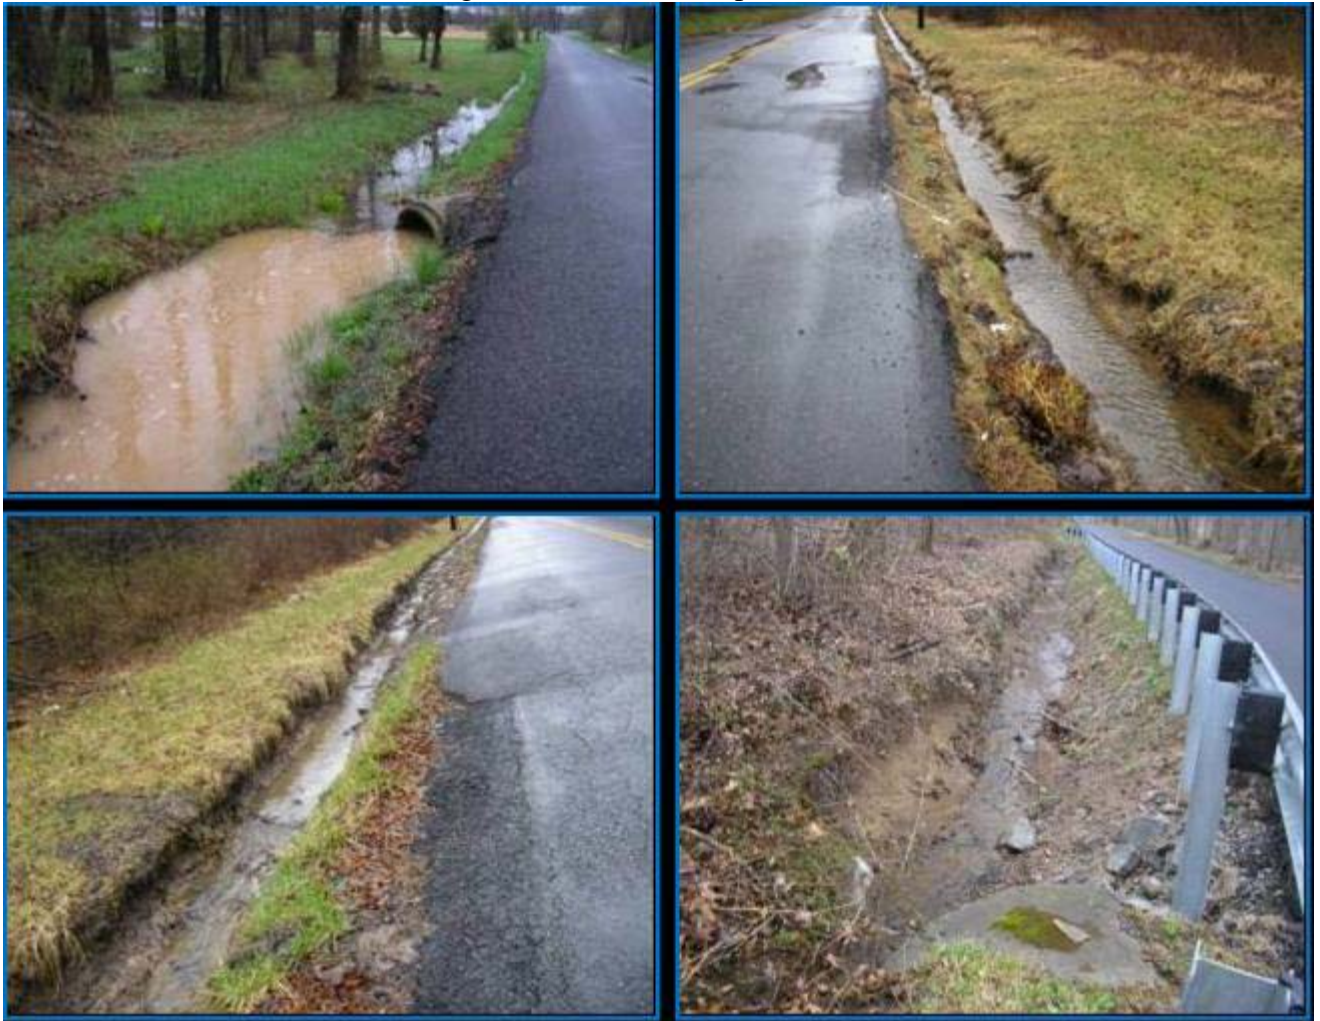
Photos 9 thru 12. Roadside drainage - erosion and transport of sediments to streams.

Most municipal road drains are cleared of debris on an annual basis. A backhoe or other scooping equipment is usually used to dredge the drainage channels. The channels become erodible and storm runoff begins to undercut the sides of the channels and transport volumes of additional sediment to the streams. **Photos 9 thru 12** show a few of the numerous examples of erosion that were observed along roadways.

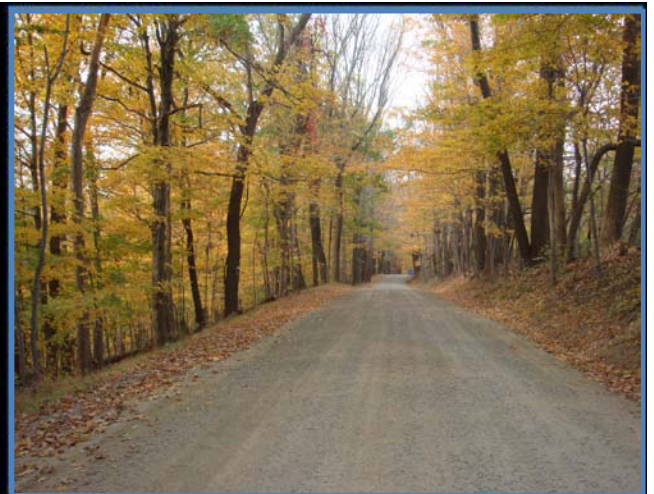
Photo 14. Pine Hill Road – dirt/gravel surface draining into Wickecheoke Creek and Plum Brook.

Photos 13 and 14 show selected sections of the road surface on Pine Hill Road. **Photos 15 thru 18** show the roadside drainage ravine erosion and sediment transport along selected segments of roadway.

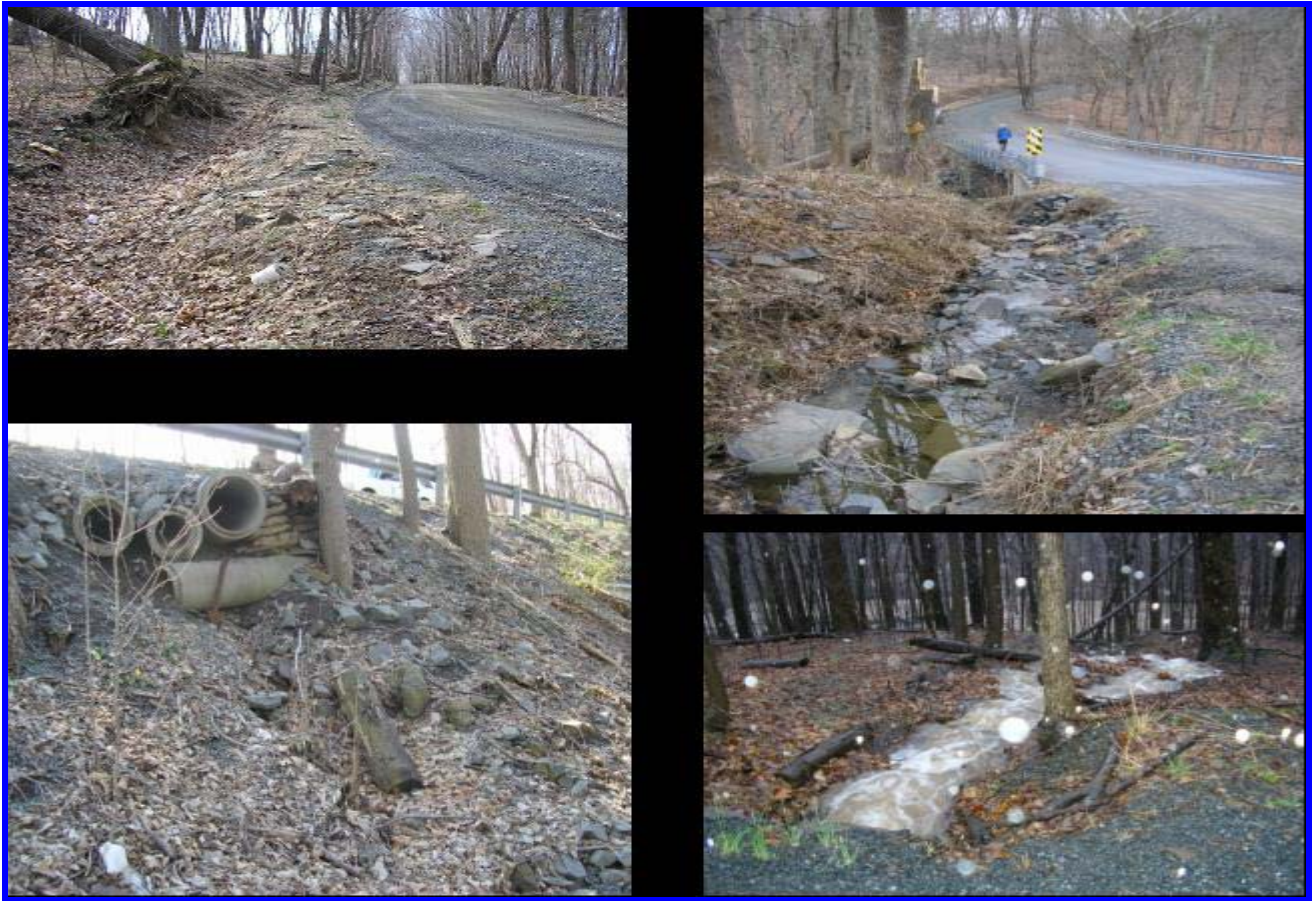
Photos 15 thru 18. Pine Hill Road - roadside erosion and discharge to Wickecheoke Creek and Plum Brook.

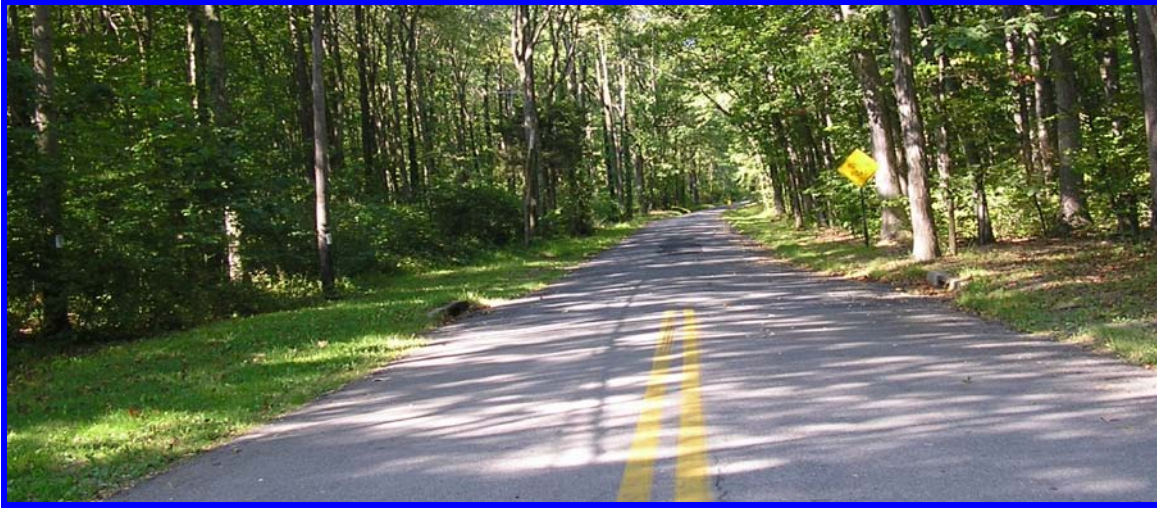
Photo 19. Elevated stormwater inlets.

Roadways that have inlet structures with a piping system for stormwater either discharge the concentrated flows to the streams, via outlets at bridge/culvert structures, or discharge into eroded drain channels that convey the flow into the stream. Many of the roadway inlet structures are higher than the elevation of the road, whereby the runoff from the road bypasses the structure and goes directly onto and infiltrates the adjoining lands. The runoff onto adjoining lands were natural drainage conditions that had existed prior to the installation of the prefabricated inlet structures and appeared to be providing successful operations. **Photo 19** shows elevated stormwater inlets, and **Photos 20 and 21** show agricultural drainage that inadvertently flows directly to an inlet structure and ultimately into an eroded drainage channel to the Wickecheoke Creek.

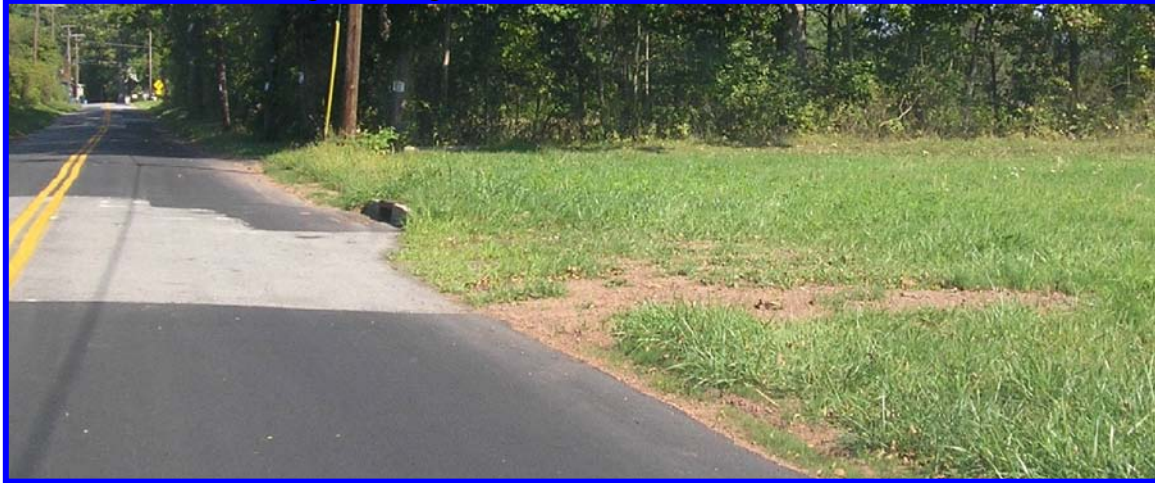
Photo 20. Field drainage flowing into roadside stormwater inlet.

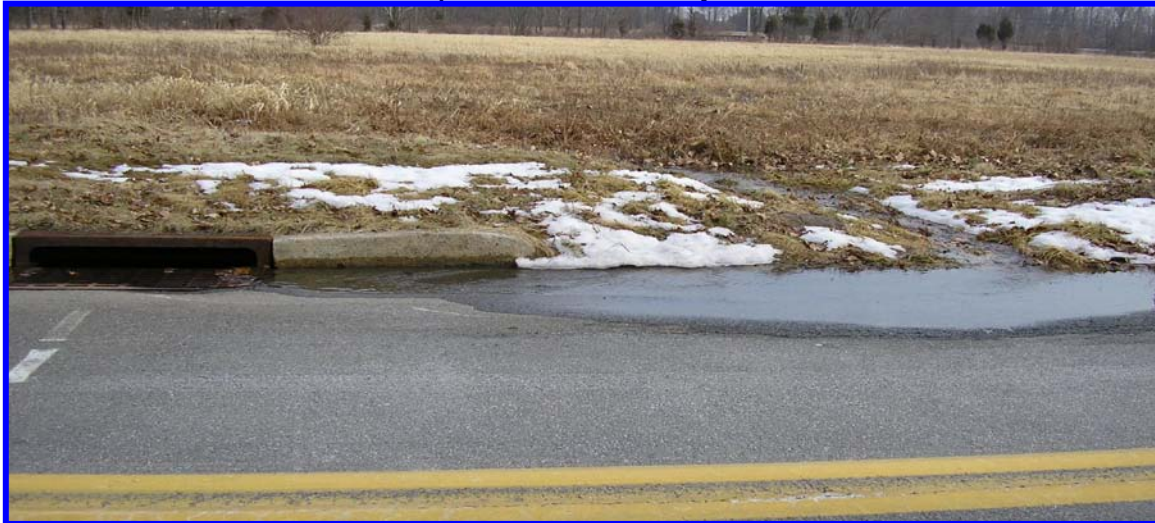
Photo 21. Storm runoff from crop field routed directly into roadside drain.

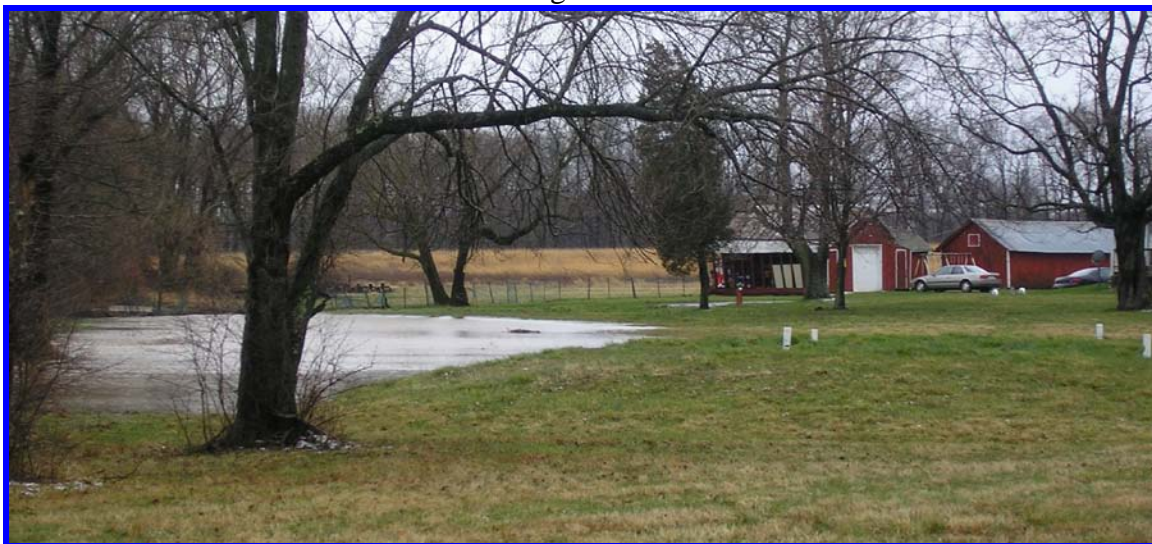
Photo 22. Septic system installed in flood plain. Photo taken during higher-flow, but the flow condition was not considered flooding.

Thin soil depth, shallow and fractured bedrock, seasonally high or perched ground water table producing saturated soil, and low-permeability soils create areas that are not suitable for septic system installation and function. **Photo 22** shows a system that was installed in the floodplain of a tributary to Lockatong Creek.

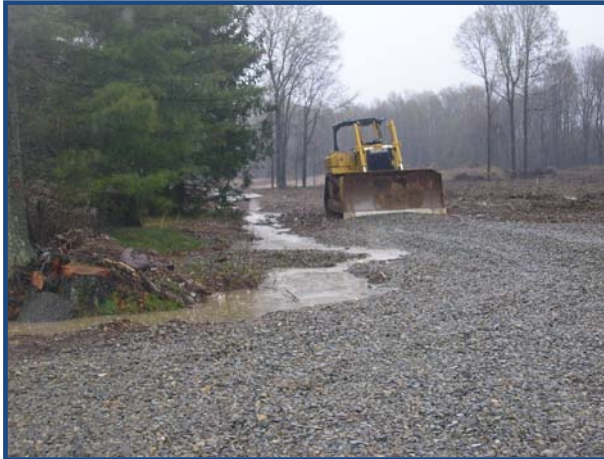
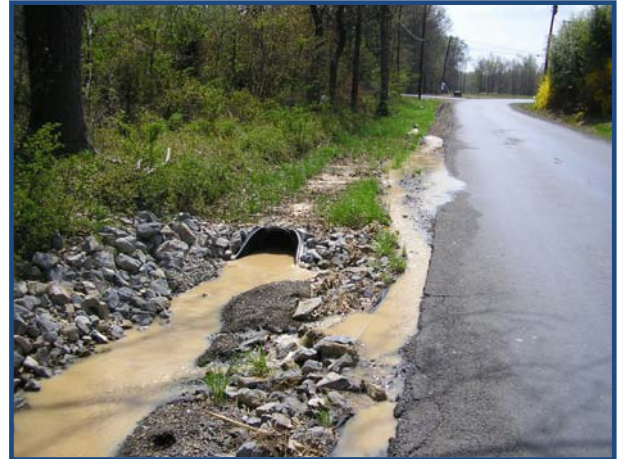
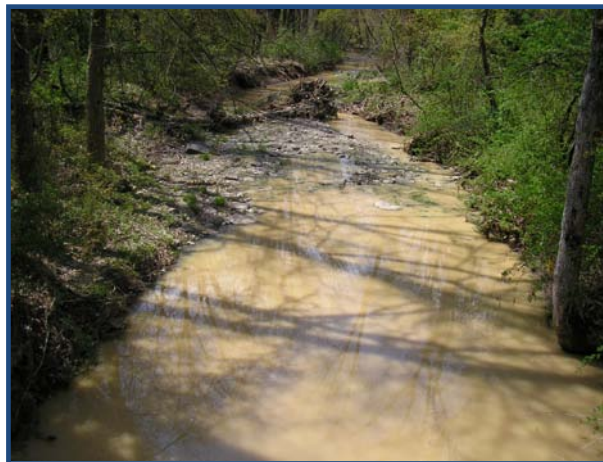
Photos 23 thru 25. Stormwater and sediment load from construction site on Barbertown-Point Breeze Road, impacting Muddy Run.

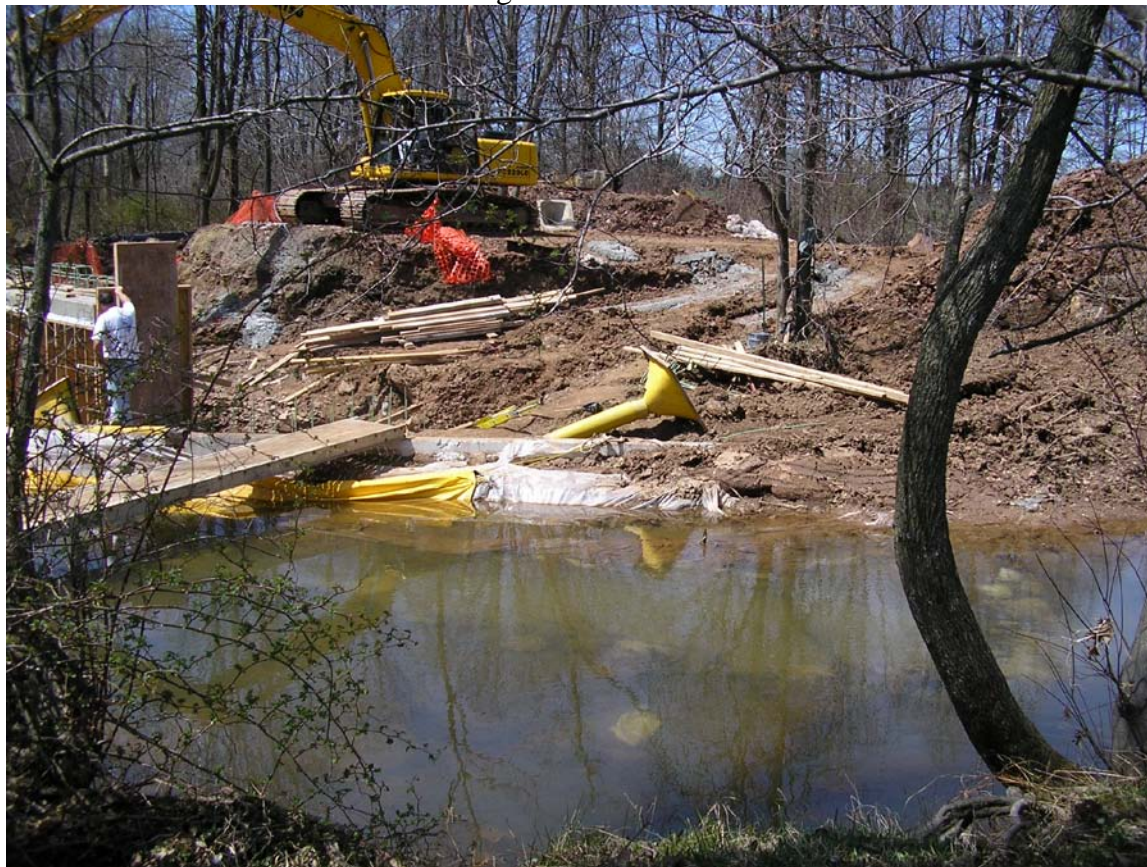
Photo 26. Potential erosion from bridge-construction site.

Bridge construction or replacement is not regulated for sediment control. The construction activity is scheduled to conclude in a timely manner to limit the duration of sediment disturbance and possible loadings to the stream. Unanticipated higher flows and intense precipitation events can cause extensive erosion and sediment loadings to the stream at the project site. The installation of a catchment basin with storm-water pumped through sediment filters (filter bags) has been used successfully for projects sponsored by the NJ Water Supply Authority. This is one strategy that should be considered for controlling sediment loadings at bridge-construction sites. **Photo 26** shows bare soils susceptible to erosion during the bridge replacement project at Lockatong Creek on Union Road.

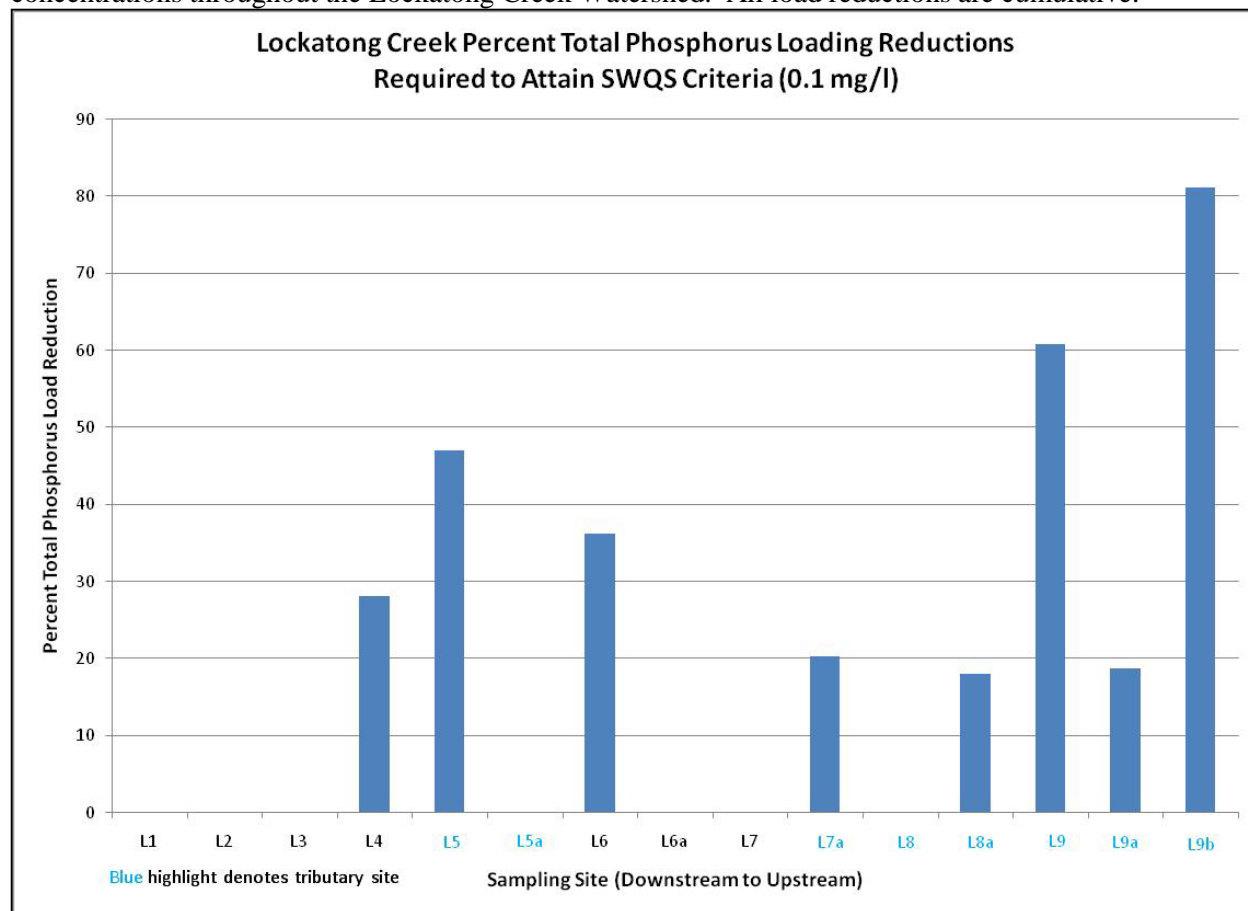
Figure 3. Estimated loading reductions to attain SWQS, targeting maximum total phosphorus concentrations throughout the Lockatong Creek Watershed. All load reductions are cumulative.
