Lockatong Creek

Stream Visual Assessment Results and Restoration Plan

**New Jersey Water Supply Authority
Final Report: September 2008**

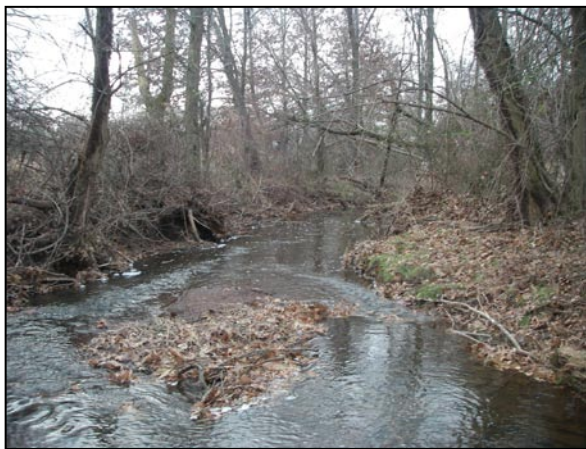
SVAP L-5

SVAP # L-5 (8/good) is located on a tributary to the main stem just upstream of Lower Oak Grove Road. The scores for this site were mostly 8 to 10, although a 6 was given for instream fish cover.

The riparian buffer on each bank is minimal, approximately 10 to 25 feet wide and of poor quality. The reach was identified as a good site for **riparian buffer restoration**. The stream banks were two to three feet high, giving the stream access to the floodplain during storm flows. The substrate was dominated by large shale, and some fine sediment was observed. The channel was sinuous with deep pools and in-

stream cover for fish and macroinvertebrates, although few riffles were observed. A small weir was observed in this reach, constructed of rock and geotextile. The weir backed up water slightly; fewer riffles were observed upstream of the weir than downstream. Land use in the vicinity of the reach consisted of residential property and large fields.
